8527 STAYTON RD

TURNER, OR

**Oregon
Farm & Home**
★ BROKERS ★

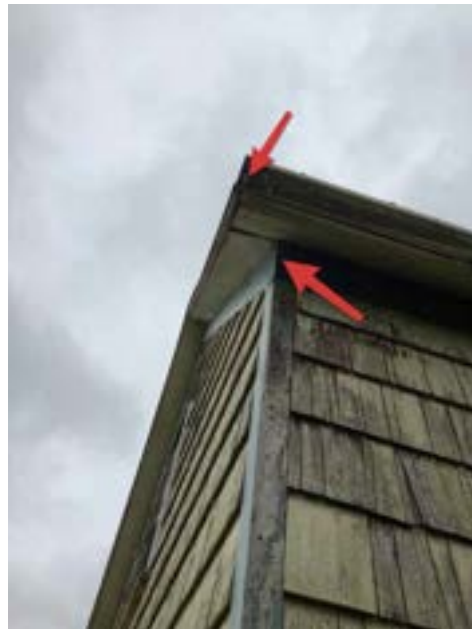
Fascia/Eave Wood Rot (Representative Picture)

Contact a qualified roofing professional.

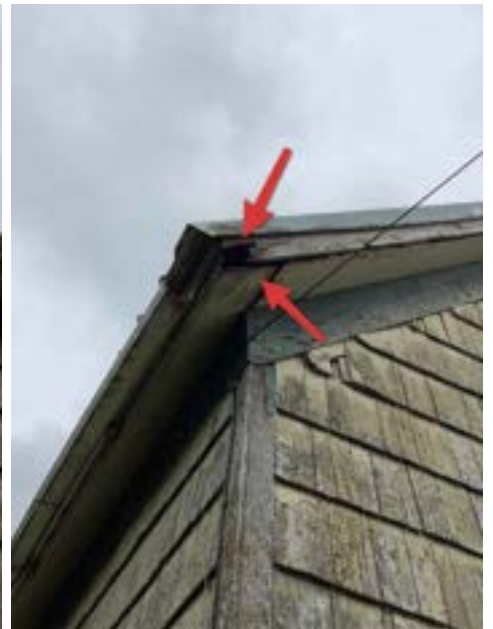
Fascia/Eave Wood Rot (Representative Picture)

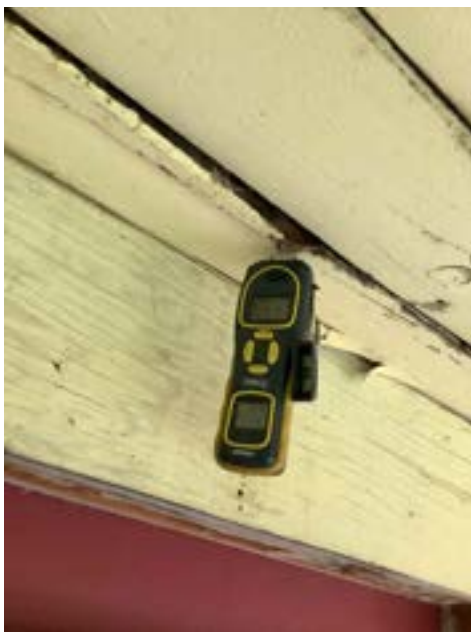
Fascia/Eave Wood Rot (Representative Picture)

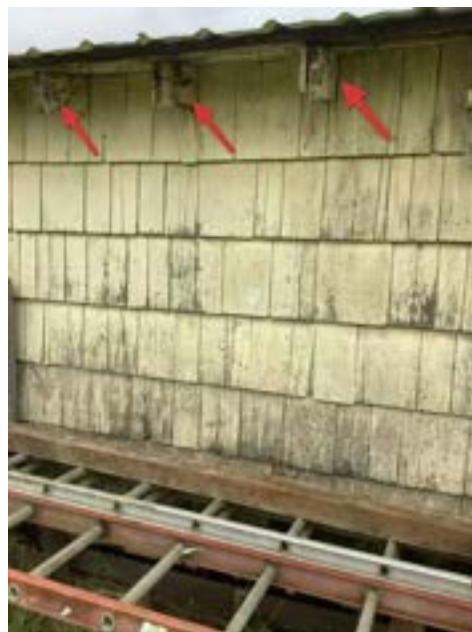
Rafters Wood Rot (Representative Picture)

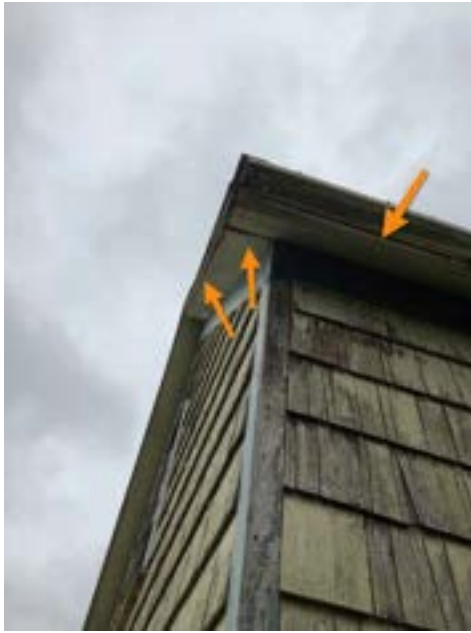
Picture 1a - Eave Panel Gaps (Representative Picture)

Contact a qualified roofing professional.

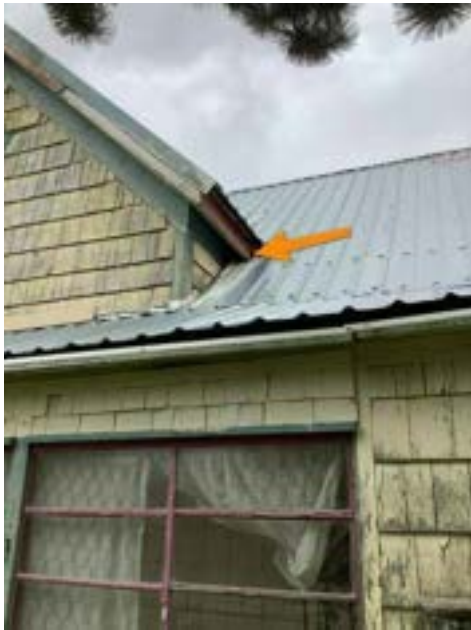
Fascia in Contact With the Roof
(Representative Picture)

Contact a qualified roofing professional.

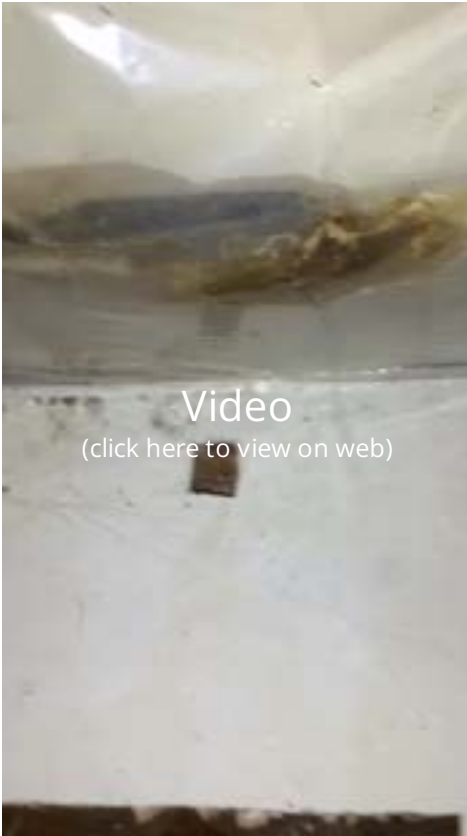
Signs of An Active Leak - Bedroom (First Floor - On Right)

Contact a qualified roofing professional.

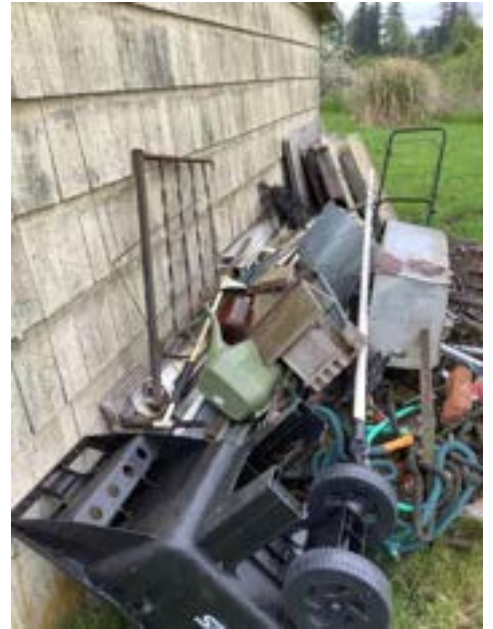
Various obstructions along the exterior right side (Side B) limited the ability of the inspector to fully assess and view the siding and associated structural components. We recommend removal of the obstructions and a re-inspection by a qualified/skilled individual to ensure no issues are present.

Limitations/Obstructions - Side B

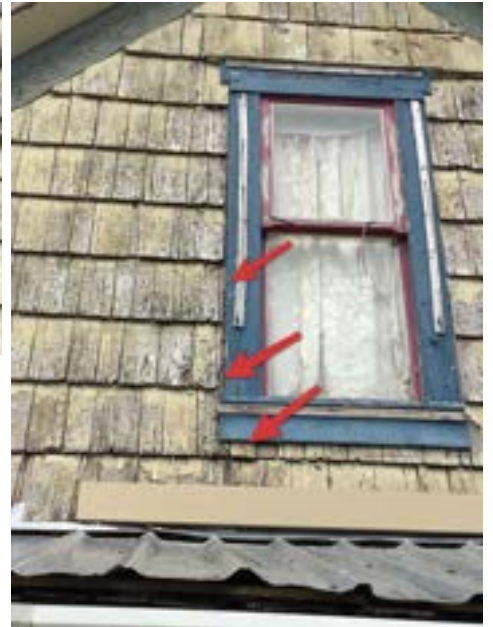
Siding/Trim Wood Rot (Representative Picture)

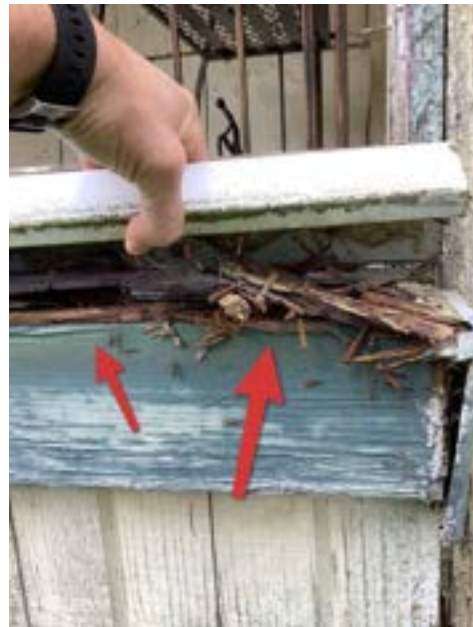
Siding/Trim Wood Rot (Representative Picture)

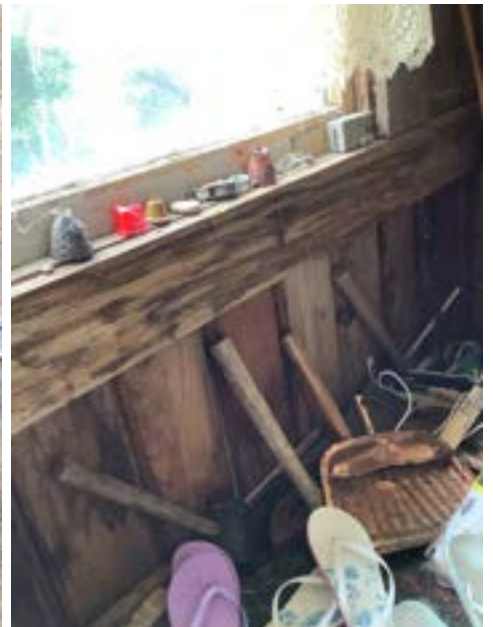
Siding/Trim Wood Rot (Representative Picture)

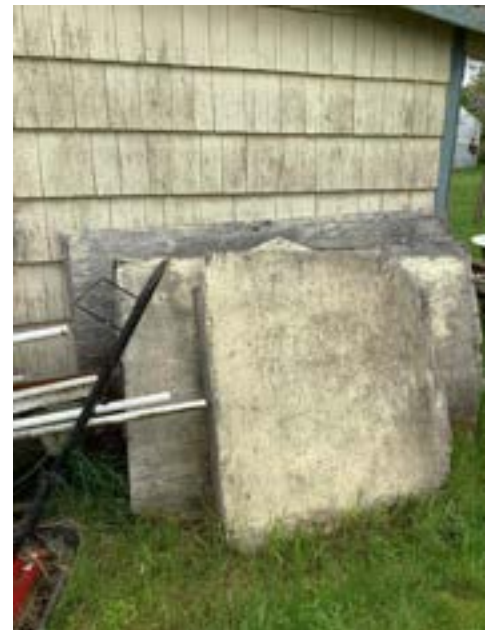
Wood in Contact With Siding - Side B

Recommended DIY Project

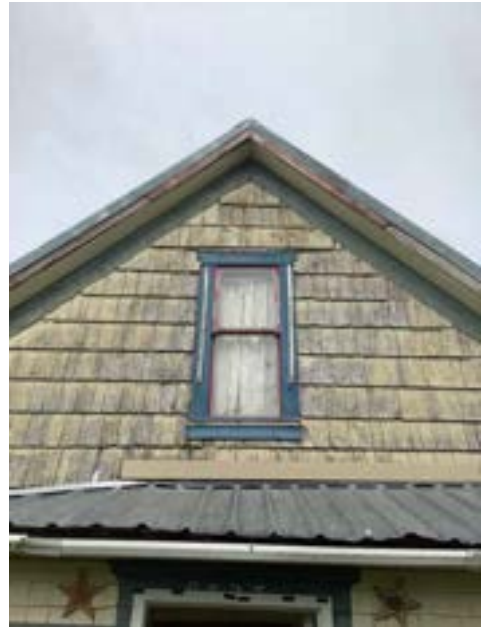
Siding/Trim Paint Deteriorating (Representative Picture)

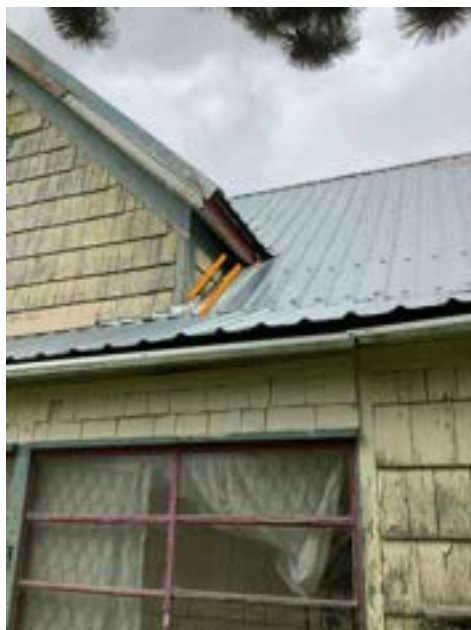
Siding in Contact With Roof (Representative Picture)

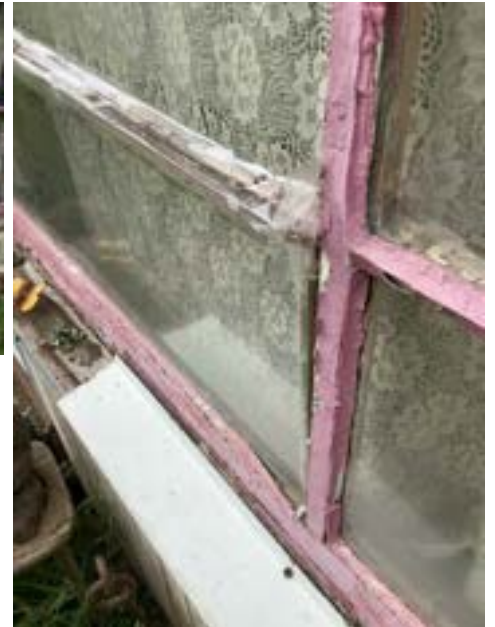
Window Trim/Frame Wood Rot
(Representative Picture)

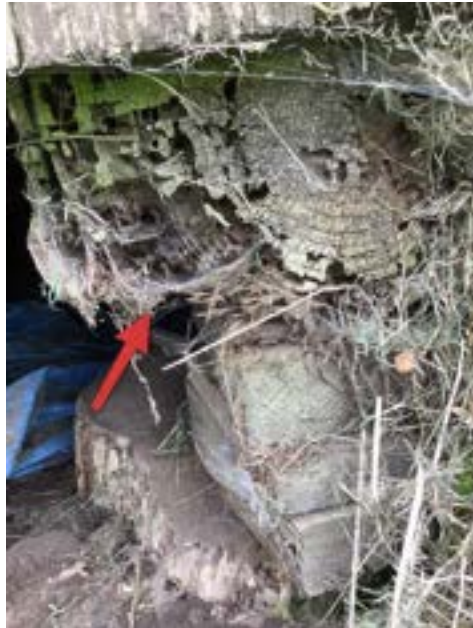
Sub-Floor Structure Wood Rot/Damage - Crawl Space (Representative Picture)

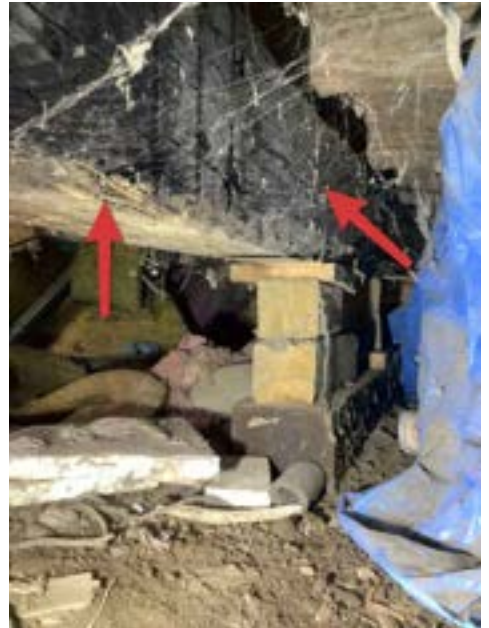
Sub-Floor Structure Wood Rot/Damage - Crawl Space (Representative Picture)

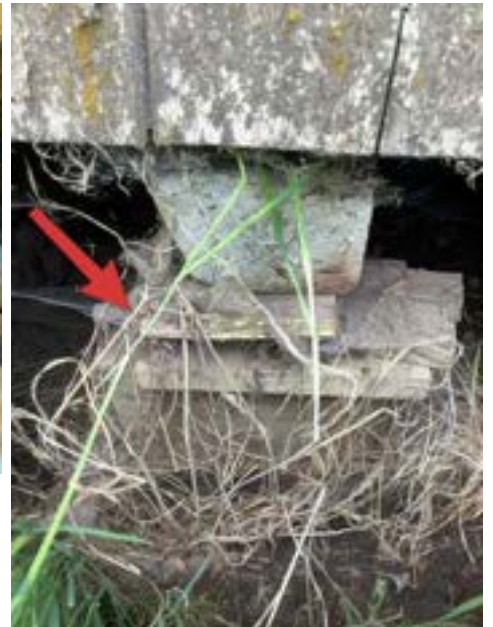
Floor Structure Improperly Braced - Crawl Space (Representative Picture)

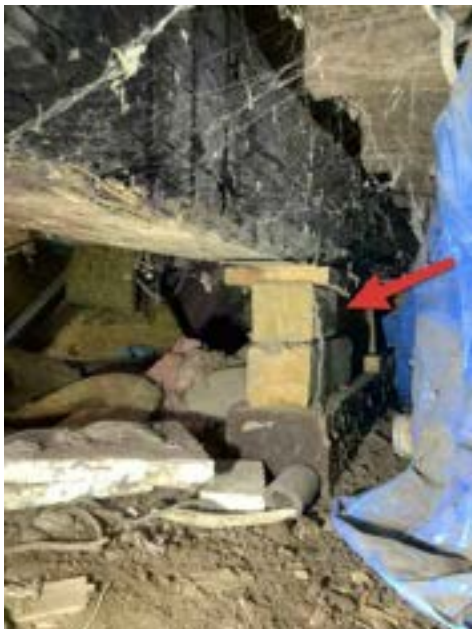
Floor Structure Improperly Braced - Crawl Space (Representative Picture)

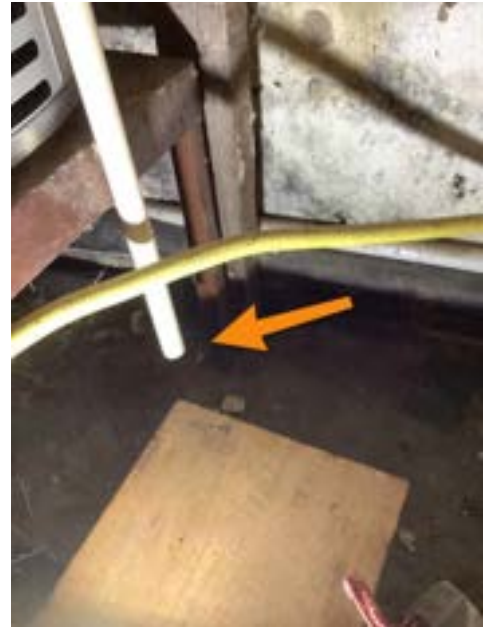
TPR Valve Discharges Onto Floor - Utility Room (First Floor)

Contact a qualified plumbing contractor.

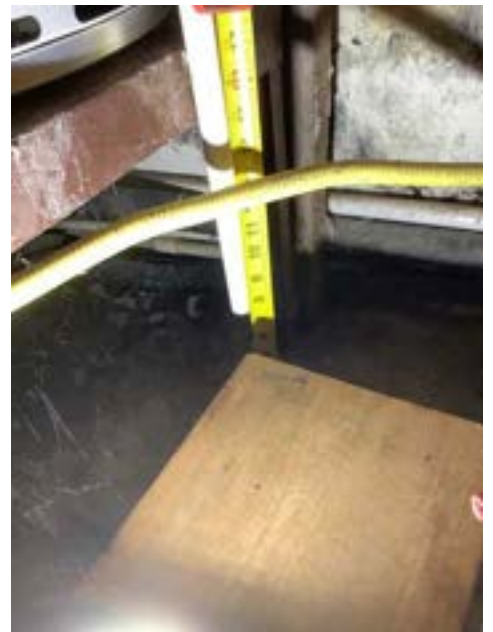
Incorrect Length of TPR Valve Piping - Utility Room (First Floor)

Contact a qualified plumbing contractor.

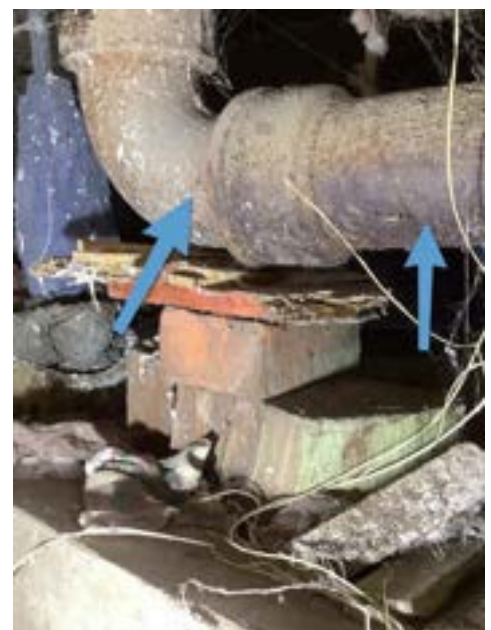
Corroded Cast Iron Piping - Crawl Space
(Representative Picture)5.4.3 Drain, Waste, & Vent
Systems

Contact a qualified plumbing contractor.

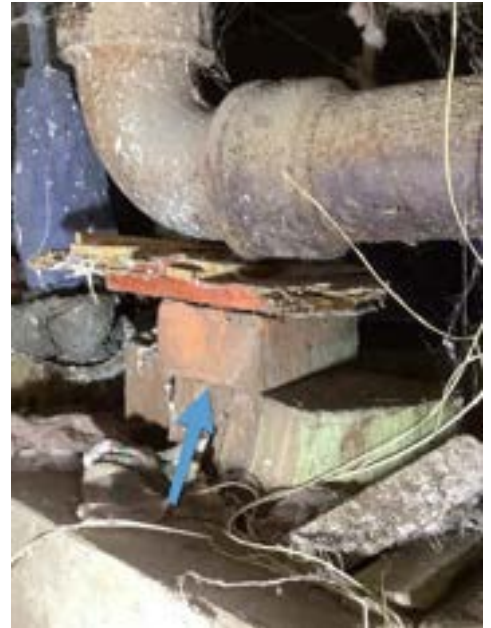
Improperly Supported Drain/Waste Piping - Crawl Space

Contact a qualified plumbing contractor.

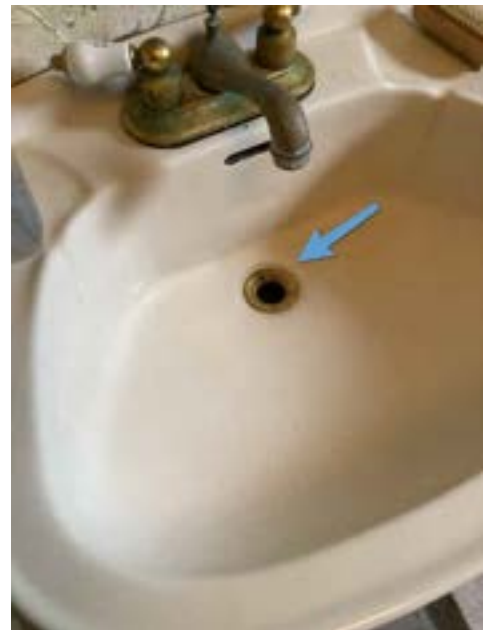
Drain Stop Missing - Full Bathroom (First Floor)

Contact a handyman or DIY project

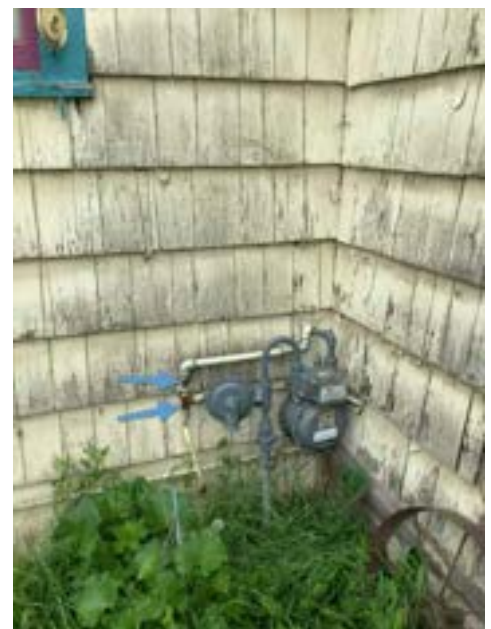
Corroded Gas Supply Line - Side B

Contact a qualified professional.

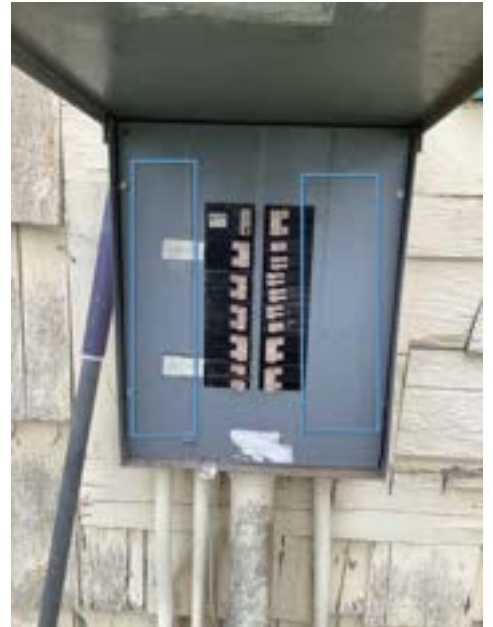
Insufficient Labeling of Electrical Panel - Side B

Contact a qualified electrical contractor.

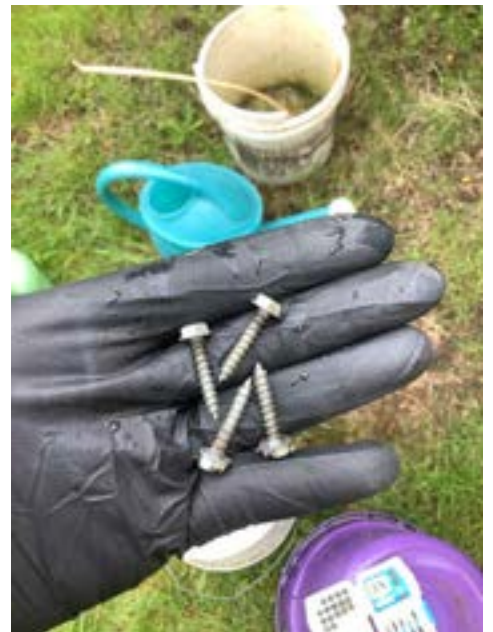
Incorrect Type of Panel Cover Fasteners - Side B

Contact a qualified professional.

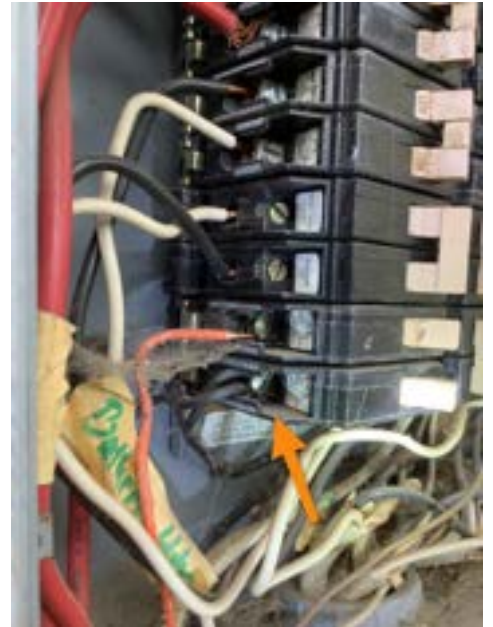
Breaker #23 Incorrectly Wired - Side B

Contact a qualified electrical contractor.

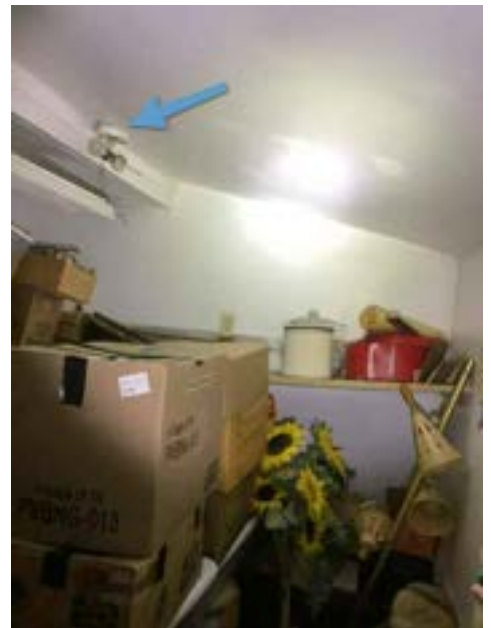
Light Fixture Cover Missing - Garage

Contact a handyman or DIY project

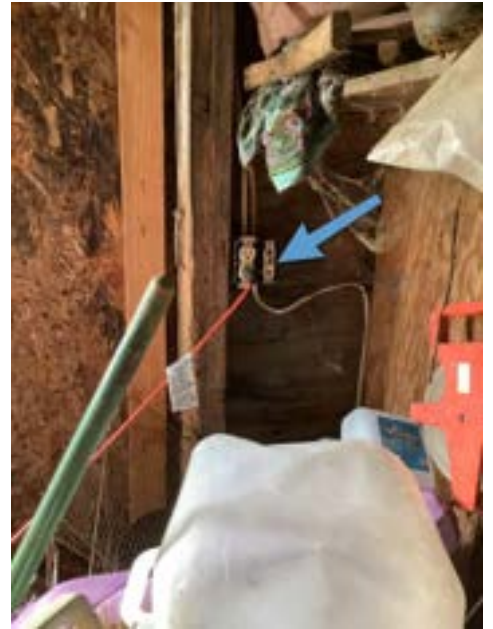
Outlet Cover Plate Missing - Garage

Contact a handyman or DIY project

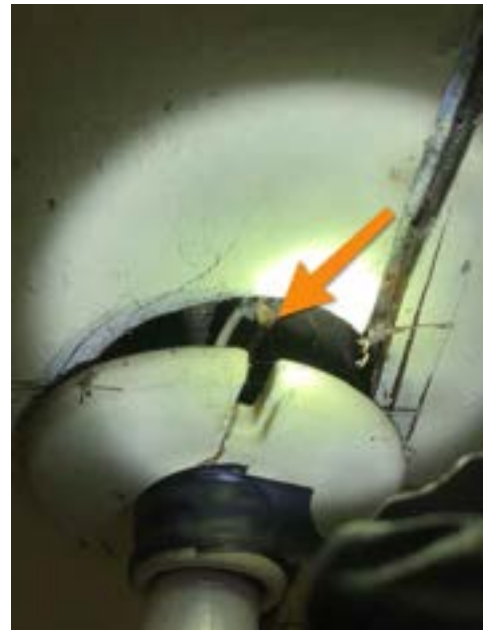
Junction Box Not Present - Side A

Contact a qualified electrical contractor.

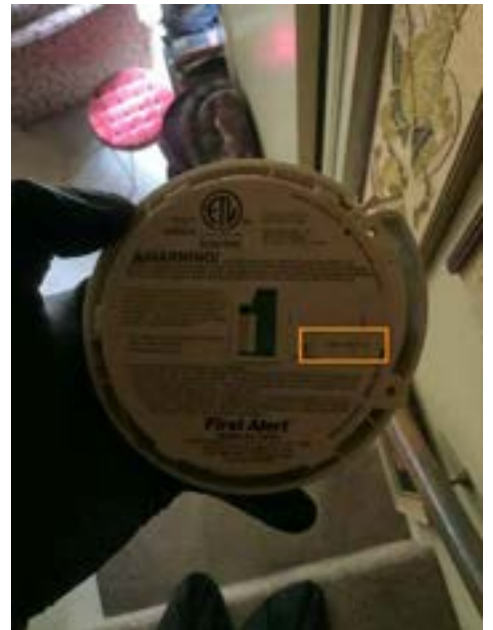
Smoke Detector Exceeds Age Requirements - Stairway (First Floor to Second Floor) (Dated 2012)

Contact a handyman or DIY project

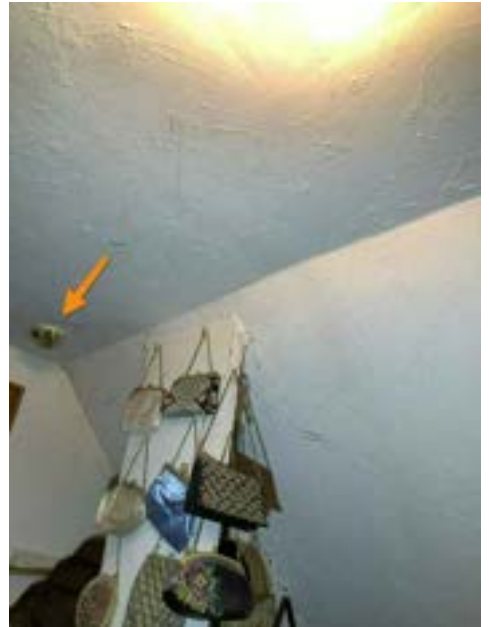
Smoke Detector(s) Damaged (Representative Picture)

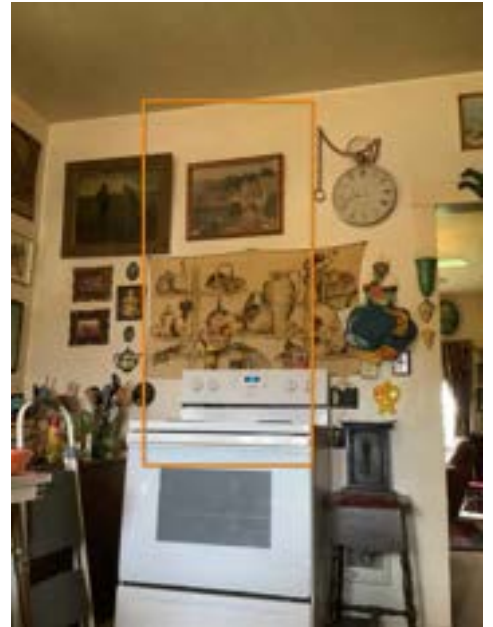
Range/Oven Exhaust System Not Present - Kitchen (First Floor)

Contact a qualified HVAC professional.

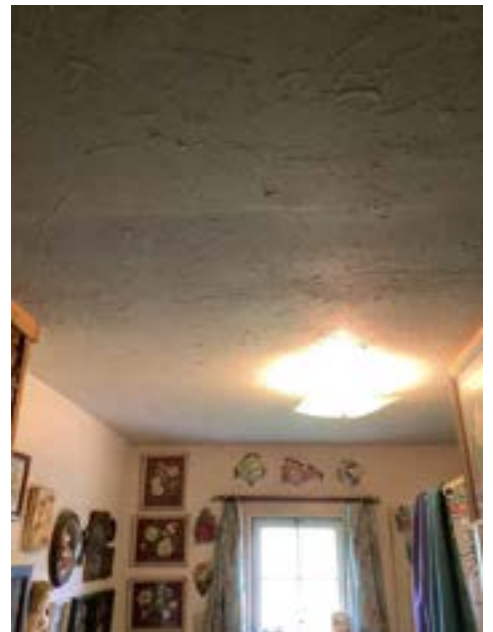
Exhaust System Not Present - Full Bathroom (First Floor)

Contact a qualified general contractor.

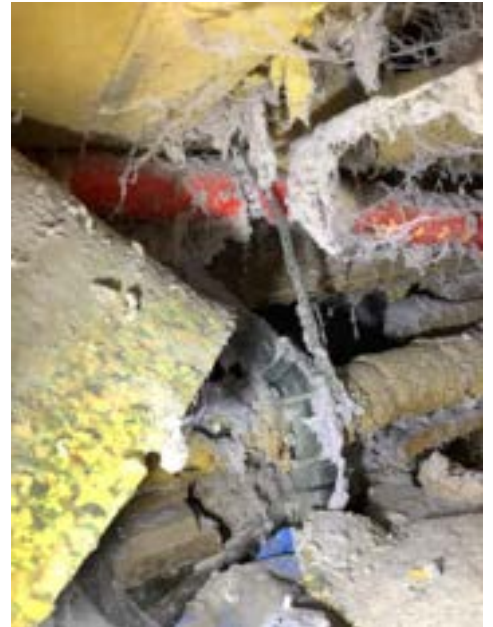
Dryer Exhaust Improperly Venting - Crawl Space

Contact a qualified general contractor.

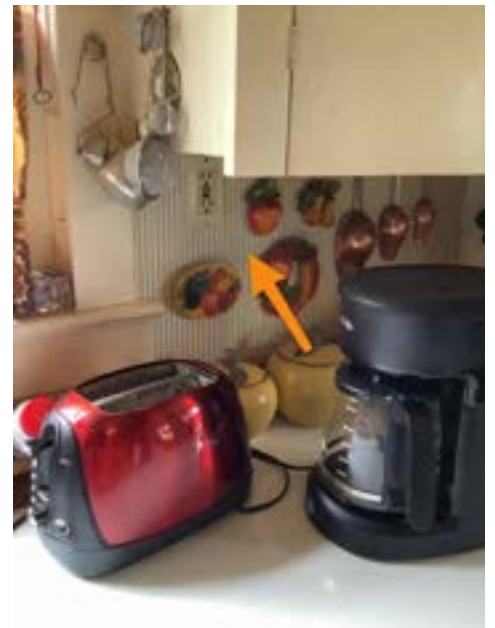
Wallpaper is present in the first floor kitchen. The presence of wallpaper/wall covering(s) prevents the inspector from fully observing/assessing the wall surfaces for possible moisture damage and or cracks within the structure. We recommend either thermal imaging or removal of the wallpaper/wall covering(s), and a re-inspection of the area to ensure no moisture damage is present.

Limitations/Obstructions - Kitchen (First Floor)

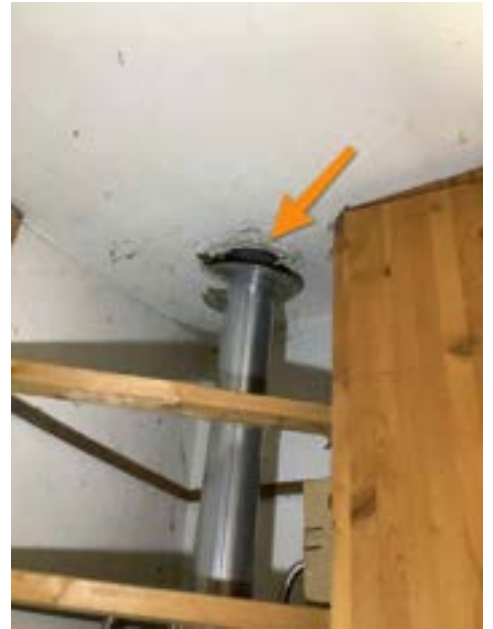
Ceiling Damaged - Utility Room (First Floor)

Contact a qualified drywall contractor.

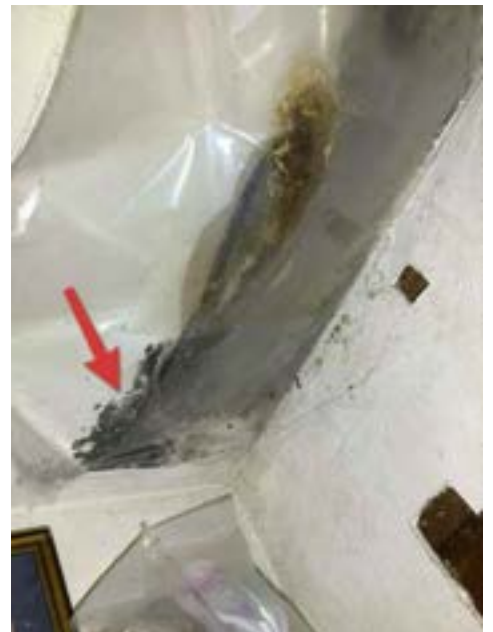
Signs of Possible Microbial Growth - Bedroom (First Floor - On Right)

Contact a qualified mold remediation contractor

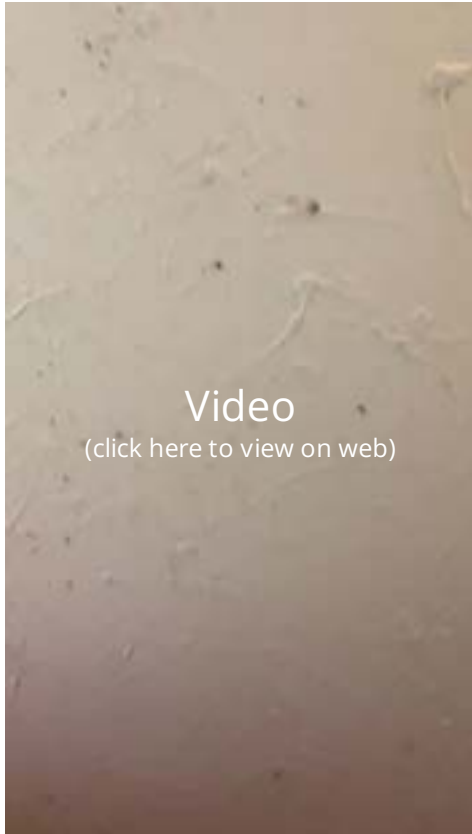
Ceiling Surface Staining/Discoloration - Full Bathroom (First Floor)

Contact a qualified general contractor.

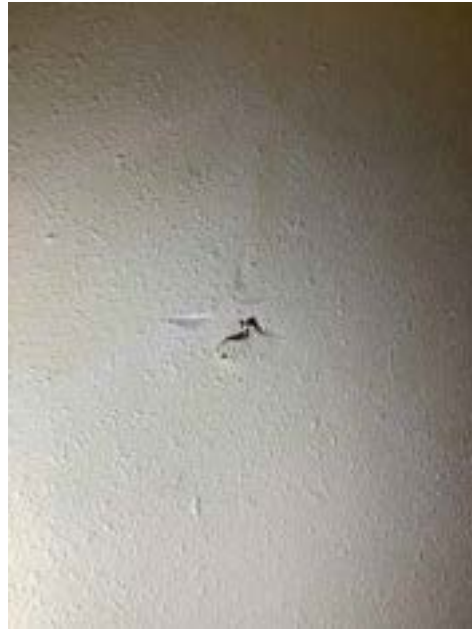
Wall Surface Damage (Representative Picture)

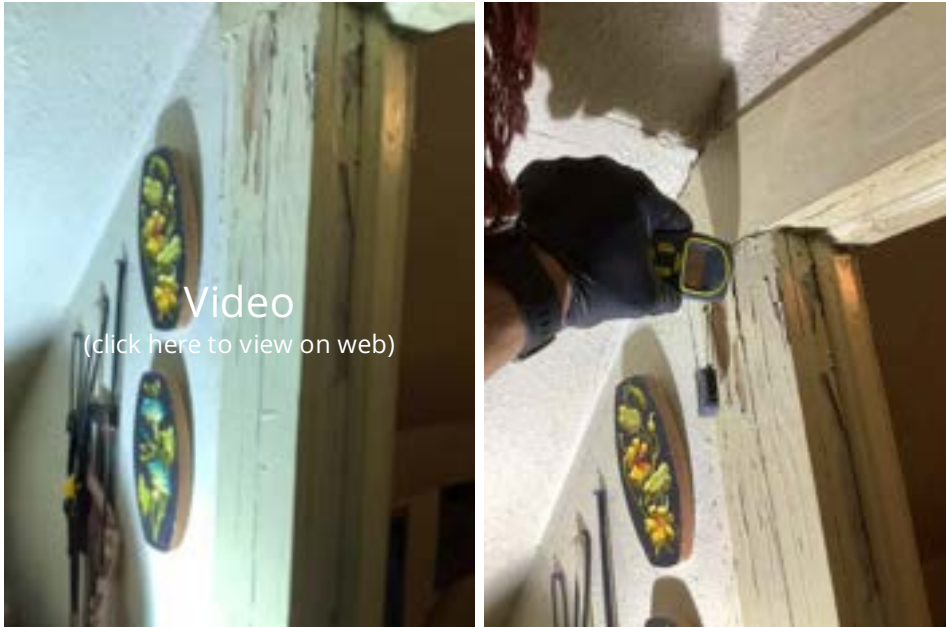
Signs of Moisture Damage - Bedroom
(Second Floor)

Contact a qualified general contractor.

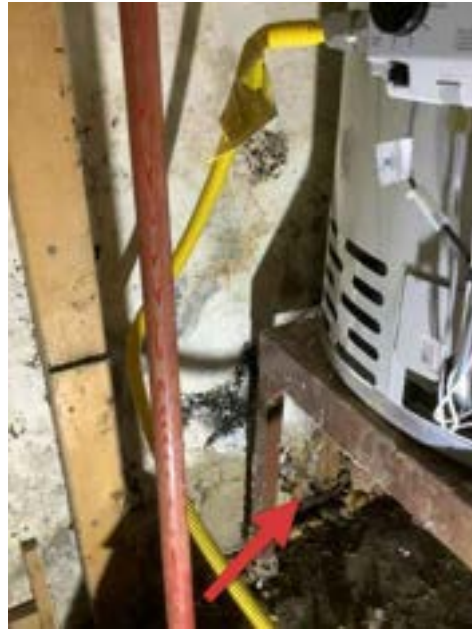
Signs of an Active Leak - Utility Room (First Floor)

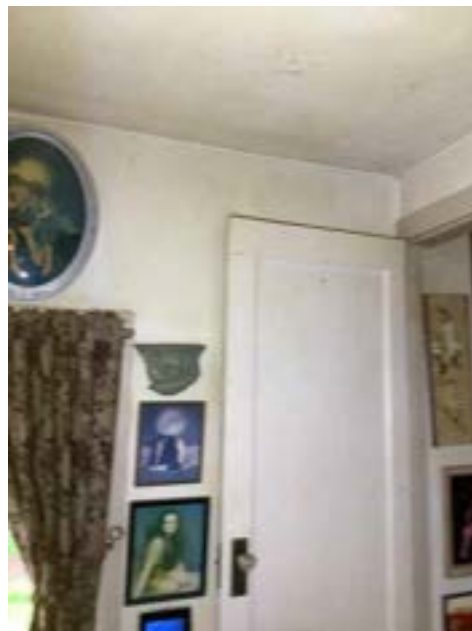
Staining/Discoloration on Wall Surface(s) (Representative Picture)

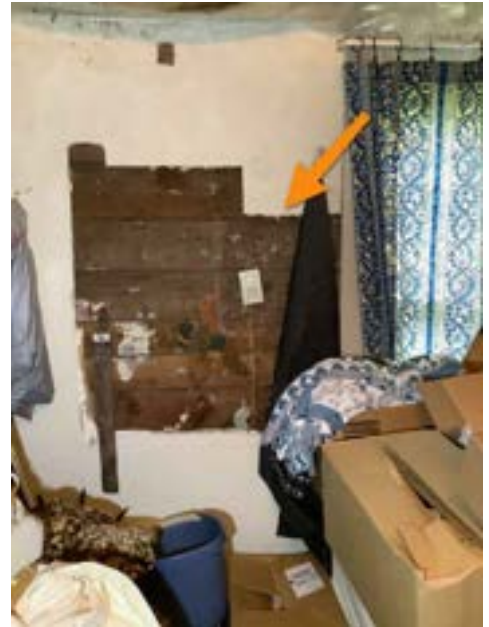
Section of Drywall Missing - Bedroom (First Floor - On Right)

Contact a qualified drywall contractor.

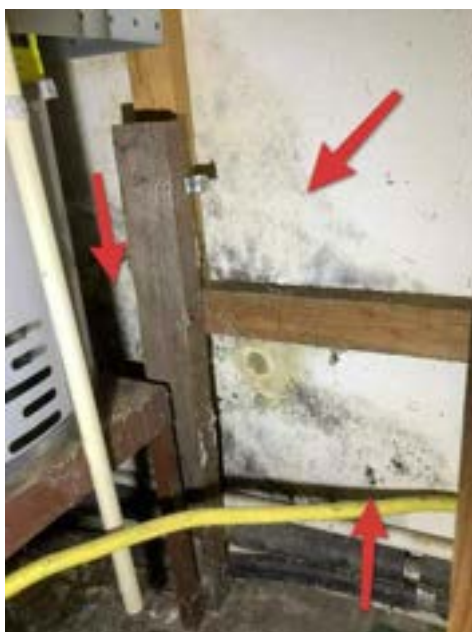
Signs of Possible Microbial Growth - Utility Room (First Floor)

Contact a qualified mold remediation contractor

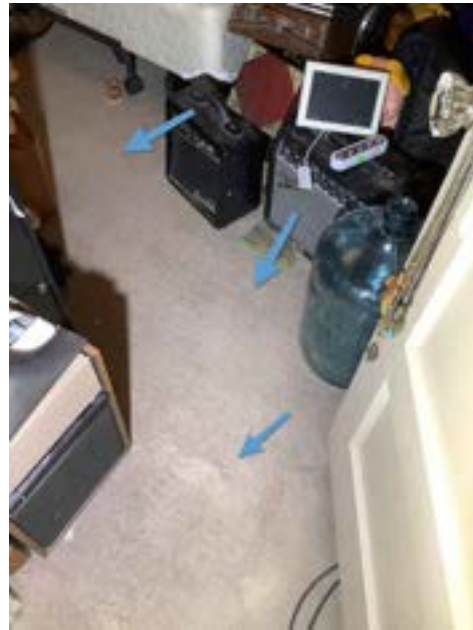
Loose Carpet (Representative Picture)

Contact a qualified flooring contractor

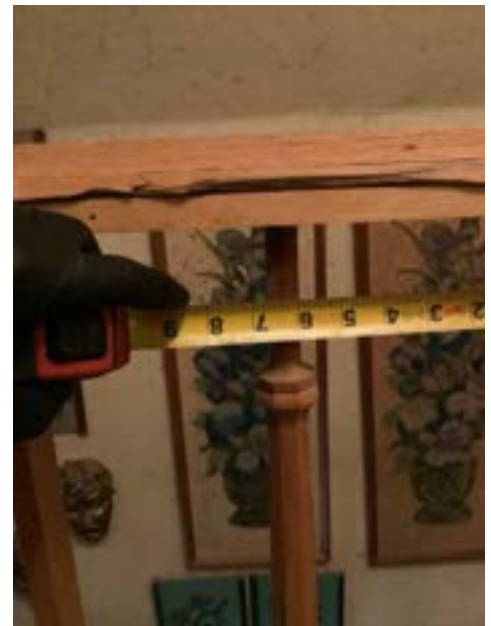
Incorrect Baluster Spacing - Hallway (Second Floor)

Contact a qualified general contractor.

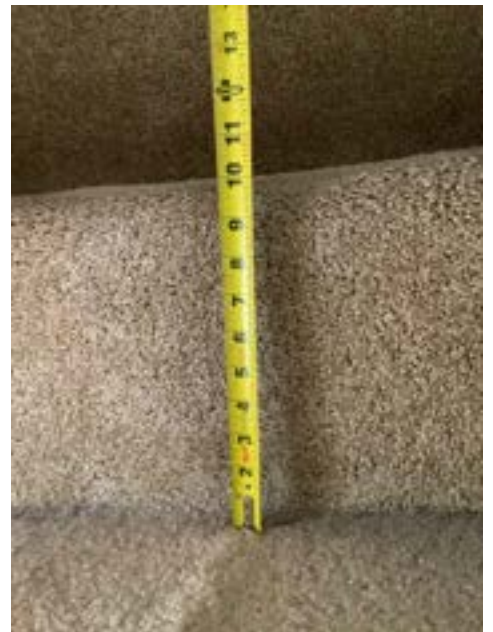
Step Riser(s) Exceed Recommended Height - Stairway (First Floor to Second Floor) (Representative Picture)

Contact a qualified general contractor.

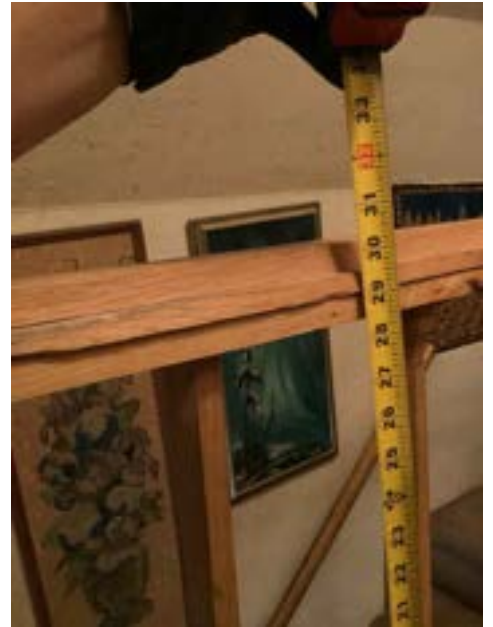
Insufficient Height of Guardrail - Hallway (Second Floor)

Contact a qualified general contractor.

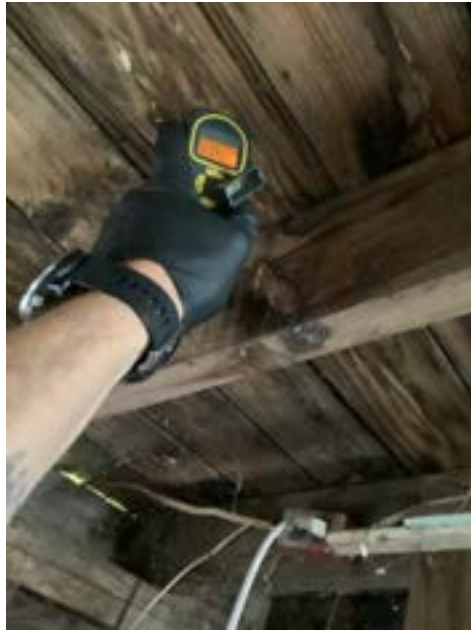
Ceiling Structure Wood Rot - Garage (Representative Picture)

Contact a qualified general contractor.

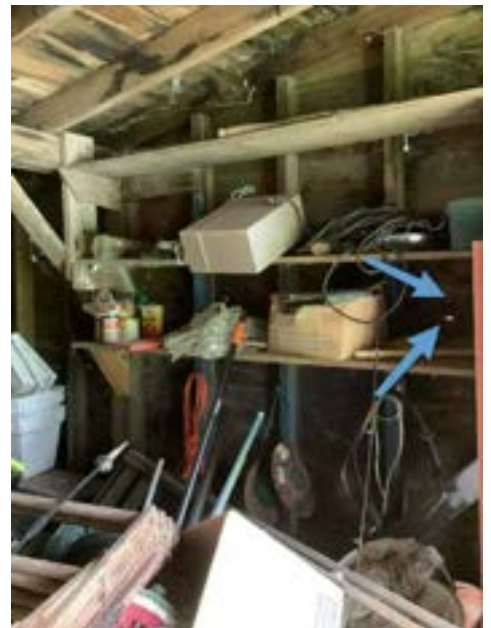
Wall Penetrations - Garage (Representative Picture)

Contact a handyman or DIY project

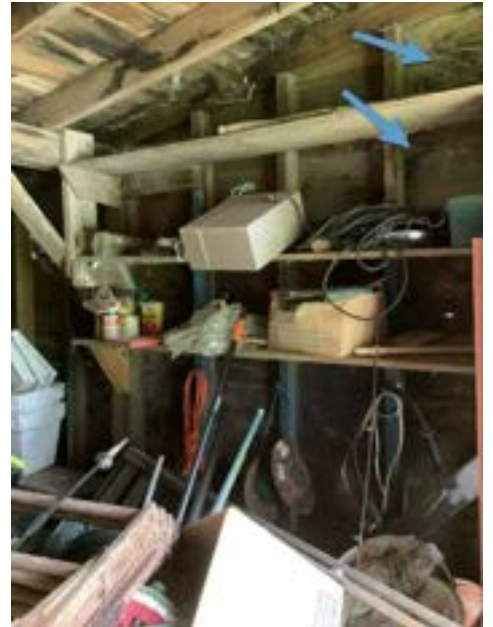
Wall Surface Staining/Discoloration - Garage (Representative Picture)

Contact a qualified general contractor.

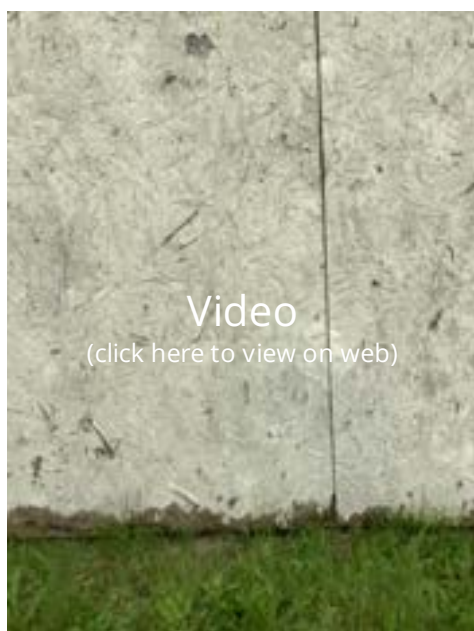
Garage Door Wood Rot - Side B (Representative Picture)

Contact a qualified garage door contractor.

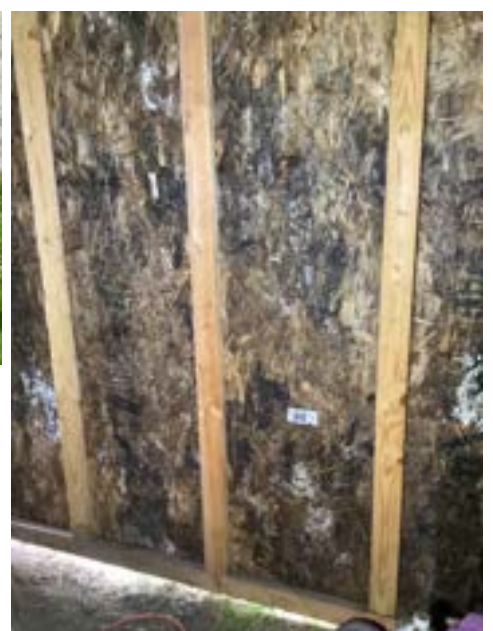
Garage Door Wood Rot - Side B (Representative Picture)

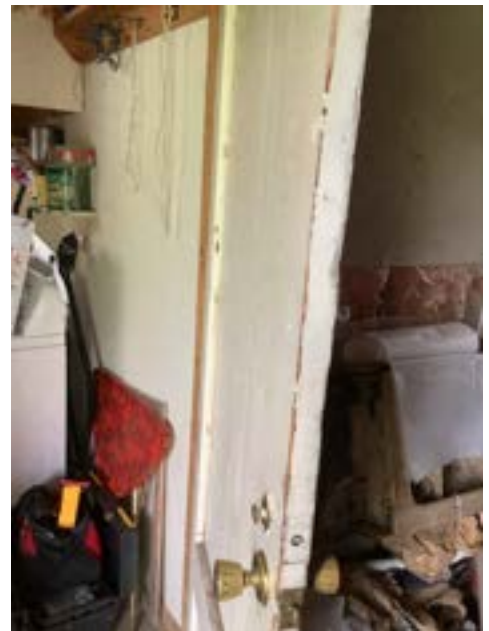
Door Does Not Meet Separation Requirements - Garage

Contact a handyman or DIY project

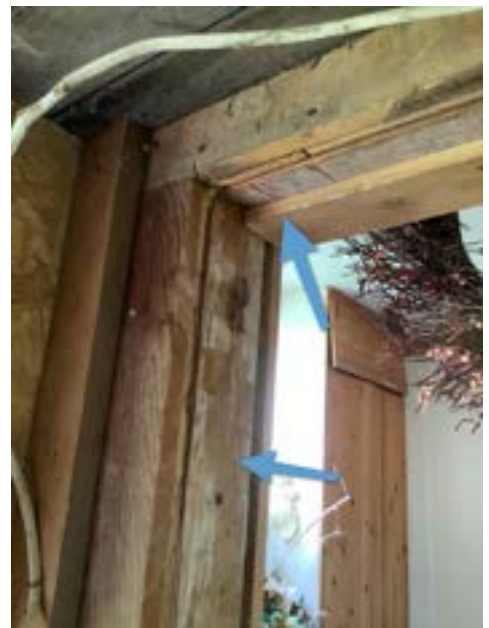
Weather-Stripping Not Present - Garage

Contact a handyman or DIY project

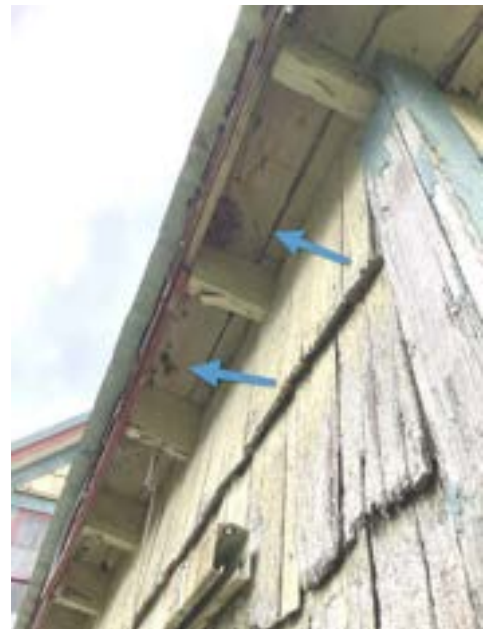
Signs of Wasp Activity (Representative Picture)

Contact a qualified pest control specialist.

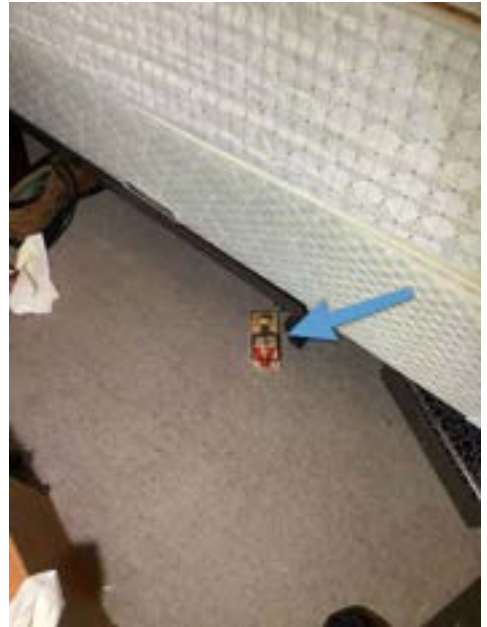
Rodent Mitigation - Bedroom (First Floor - On Right)

Contact a qualified pest control specialist.

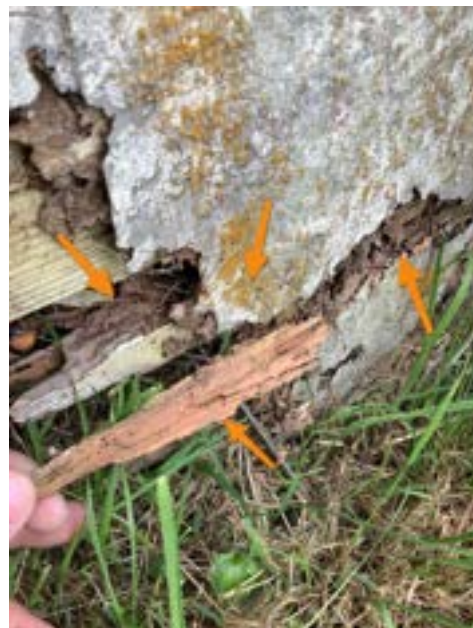
Signs of Wood Destroying Insects (Representative Picture)

Contact a qualified pest control specialist.
