8527 STAYTON RD

TURNER, OR

**Oregon
Farm & Home**
★ BROKERS ★

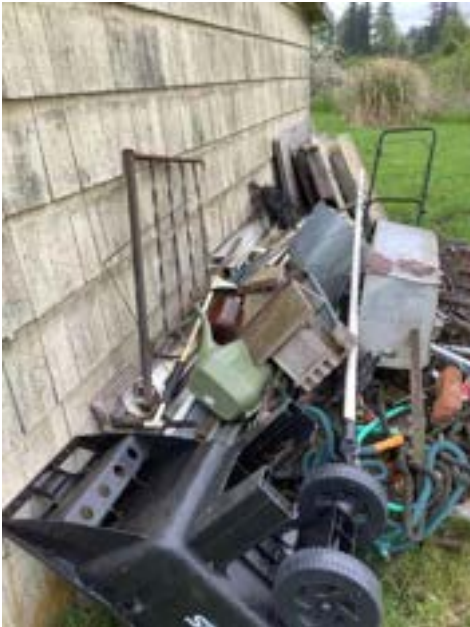
At the time of the inspection, the residence was occupied and as such various obstructions were present limiting the inspectors ability to fully assess the exterior of the home, the interior ceiling surfaces, walls, floors, electrical outlets and switches, the associated components, and portions of the systems that are present.

Limitations/Obstructions - Exterior (Representative Picture)

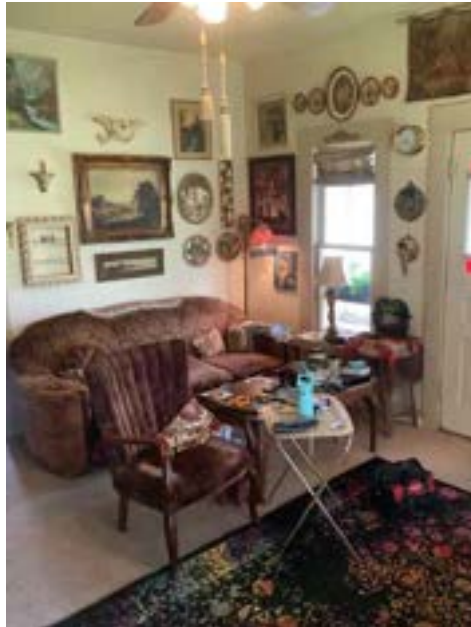
Limitations/Obstructions - Interior (Representative Picture)

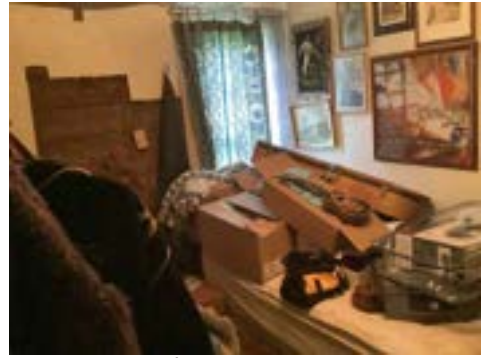
Limitations/Obstructions - Interior (Representative Picture)

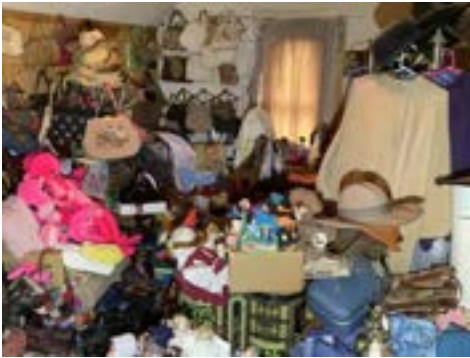
Limitations/Obstructions - Interior (Representative Picture)

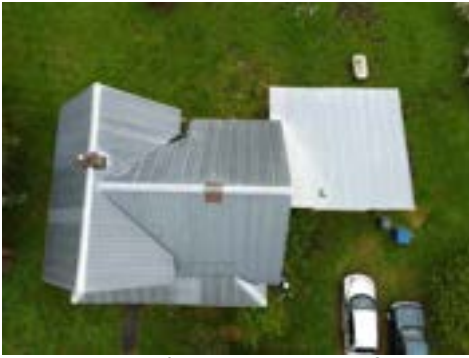
Due to the type of roof covering and the slope of the roof in conjunction with the lack of an anchor/tie-off system on the roof, the inspector was unable to traverse the roof for safety concerns. As such, the inspector was unable to fully assess the portions of the systems that are present such as, the condition of the roofing material, gutters, vents, and other such roofing system components. If desired, we recommend that a roofing contractor assess the status of the complete roof, and determine if any repairs are needed. Additionally, the inspector used a drone to assess portions of the roof and the associated system and components on present on the roof. The use of drone technology is limited to a visual assessment only and can be impacted by the conditions present on the day of the inspection.

Limitations/Obstructions - Roof
(Representative Picture)

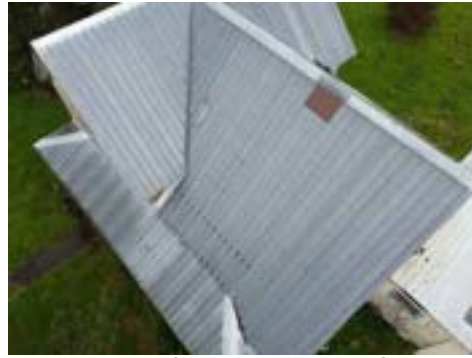
Limitations/Obstructions - Roof
(Representative Picture)

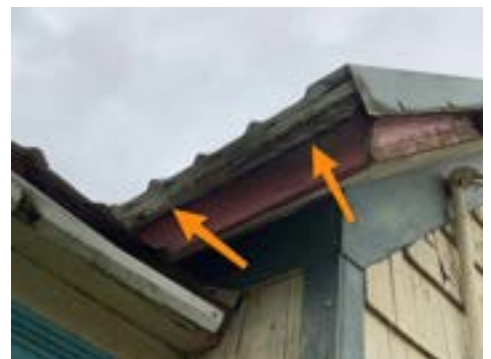
Multiple Roofing Layers
(Representative Picture)

Recommendation

Contact a qualified roofing professional.

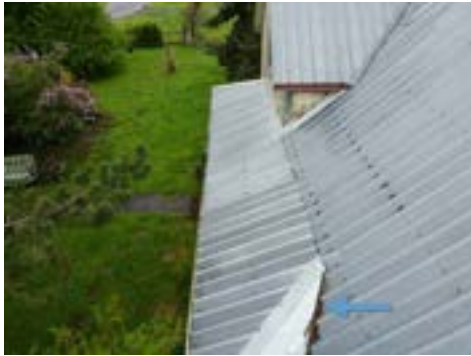
2.1.2 Coverings

Corroded Roof Covering
(Representative Picture)

Recommendation

Contact a qualified professional.

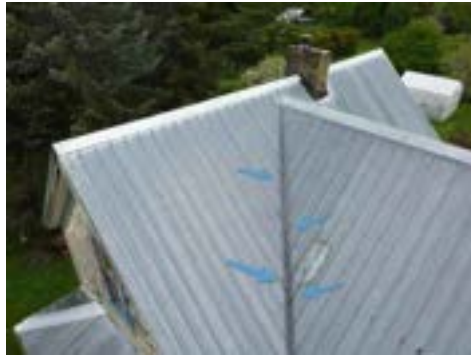
Corroded Roof Covering
(Representative Picture)

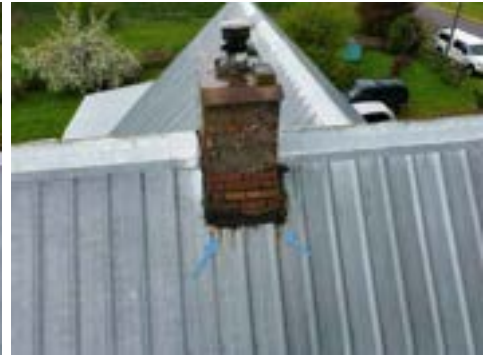
Corroded Roof Covering
(Representative Picture)

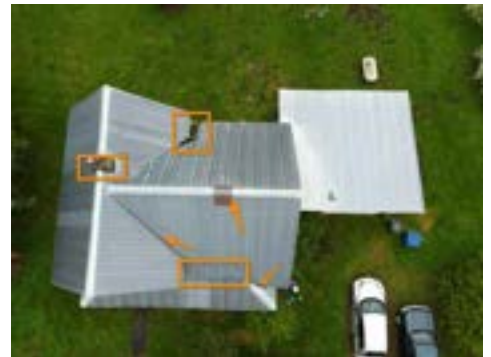
Areas of what appear to be patching was observed on the roof. We recommend further evaluation by a licensed roofing contractor to ensure the patching has been appropriately installed and no issues are present.

Roof Patching

Contact a qualified roofing professional.

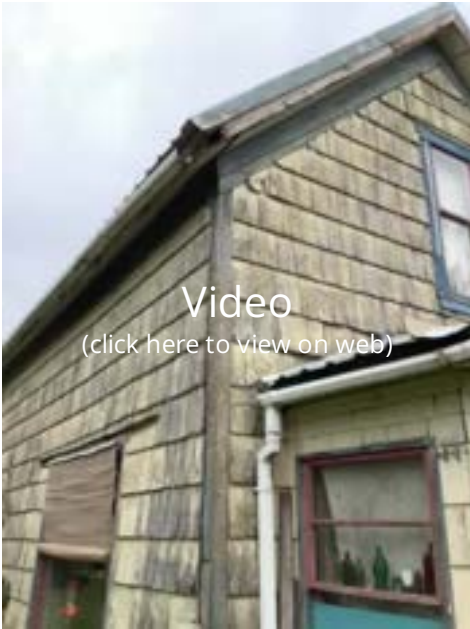
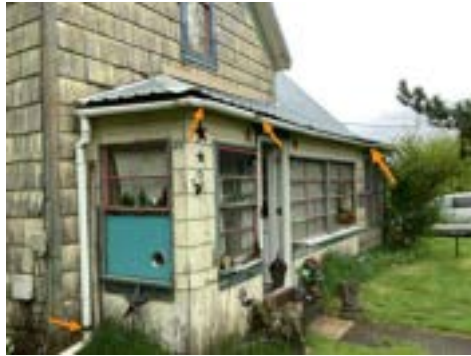
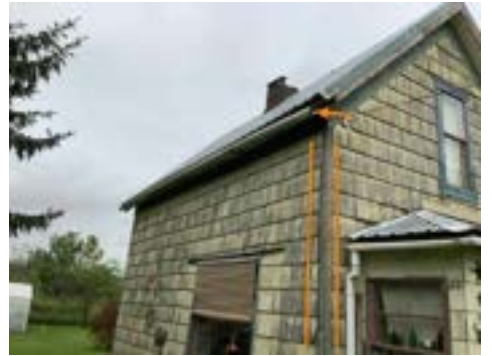
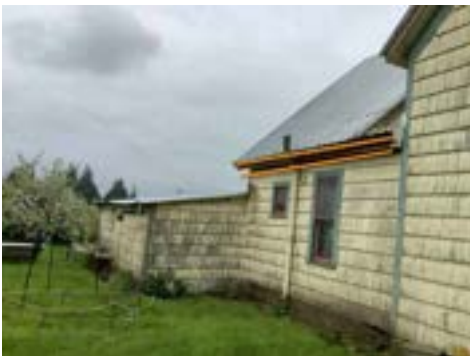
Sections of the gutter rails and associated downspouts are damaged and/or missing on **all** sides of the home. If left unaddressed, the damage could lead to corrosion and further deterioration of the gutter rails/downspouts, moisture accumulation in the fascia and eaves, and water discharging from the gutters/downspouts around the foundation; which can lead to excessive moisture accumulation in the soil around the foundation and possible foundation/structural movement. We recommend a licensed gutter contractor assess and repair as necessary.

Gutter System Damaged/Not Present
(Representative Picture)

Contact a qualified gutter contractor

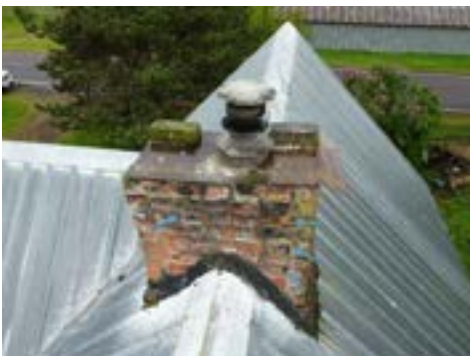
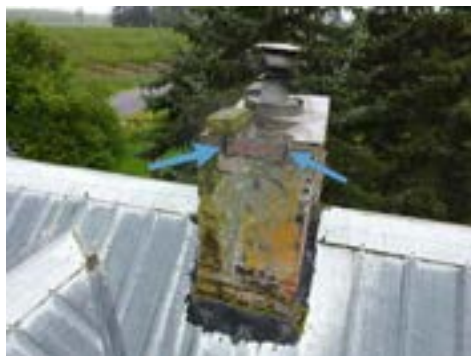
The mortar is deteriorating between the bricks in the chimney structure, located on the center ridgeline; please note, due to limitations on the roof the inspector was unable to fully assess the chimney for structural instability. We recommend evaluation and repair by a licensed chimney contractor.

Chimney Mortar Deteriorating - Center
Ridgeline

Contact a qualified chimney contractor.

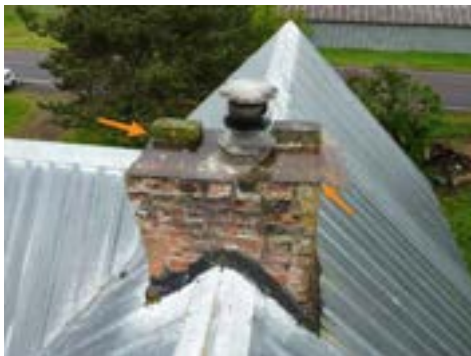
A metal sheet has been placed on top of the chimney on the center ridgeline, to serve as a make-shift chimney crown; please note, the sheet has been secured with bricks. Additionally, this has caused a gap between the crown and the vent stack. The absence of a properly installed chimney crown could lead to moisture damage resulting in deterioration of the concrete structure, the chimney flue liner, and possible moisture penetration into the interior structure of the home. We recommend assessment by a licensed chimney contractor for possible repairs to ensure the life and serviceability of the chimney.

Chimney Crown Not Properly Installed - Center Ridgeline

Contact a qualified chimney contractor.

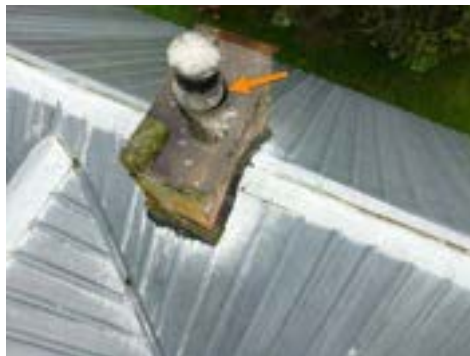
Gap Around Vent Stack - Center Ridgeline

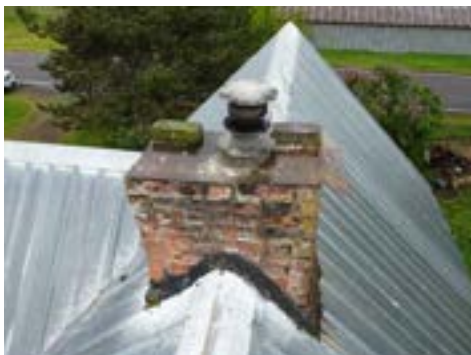
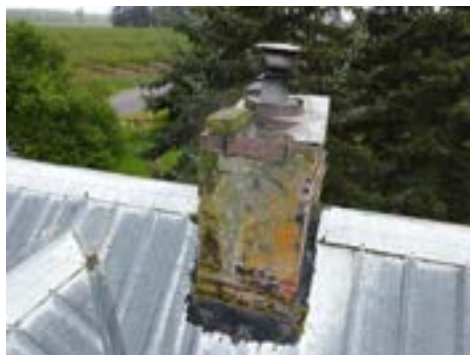
Moss growth was observed on **all** sides of the chimney structure on the center ridgeline. While this can be a common occurrence in wet weather climates, if left unaddressed, this can lead to further deterioration of the mortar resulting in structural instability. We recommend a knowledgeable/skilled individual clean the moss growth from the chimney and continued monitoring to ensure no deterioration of the structure occurs.

Moss Growth on Chimney Structure - Center Ridgeline (Representative Picture)

Contact a handyman or DIY project

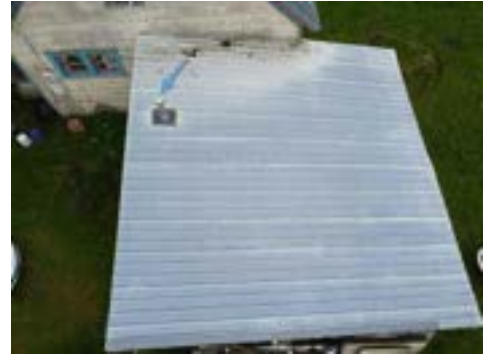
The cap on the water heater vent stack is damaged/dented located on the flat roof structure. While the cap appears to be in working condition, with continued exposure to the elements the damage could lead to corrosion and deterioration of the material. We recommend a knowledgeable/skilled individual assess and correct as needed to protect and extend the life of the material.

Vent Stack Cap Damaged - Flat Roof Structure

Contact a handyman or DIY project

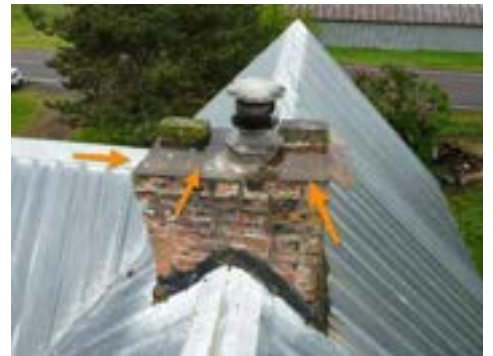
Corrosion was observed on the chimney crown located on the center ridge line. With continued exposure to the elements the corrosion could become more extensive, leading to deterioration of the material. We recommend a knowledgeable/skilled individual assess and correct as needed to protect and extend the life of the material.

Corroded Chimney Crown - Center Ridgeline

Contact a handyman or DIY project

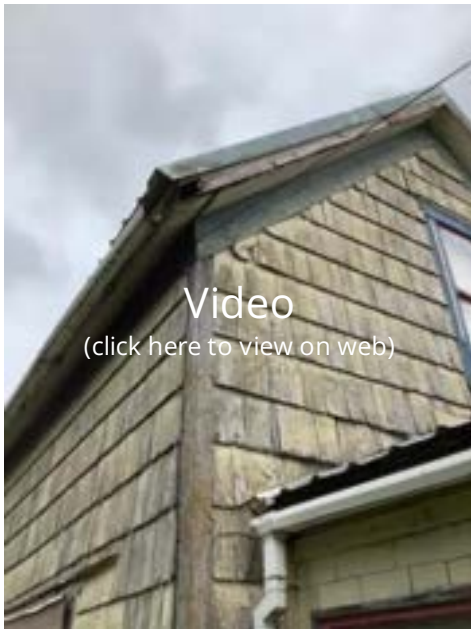
Significant wood rot was identified in the fascia **and** eaves **and** rafters on **all** sides of the home, to include the enclosed patio and garage structure; moisture readings indicate a 22.5% saturation level, at the time of the inspection. The wood rot was deemed significant due to the extent of deterioration present, as well as the amount of moisture that has penetrated into the fascia/eaves. As such, we recommend this be assessed and corrected by a licensed roofing contractor to prevent further damage to the eave structure and/or underlying structure.

Fascia/Eave Wood Rot (Representative Picture)

Contact a qualified roofing professional.

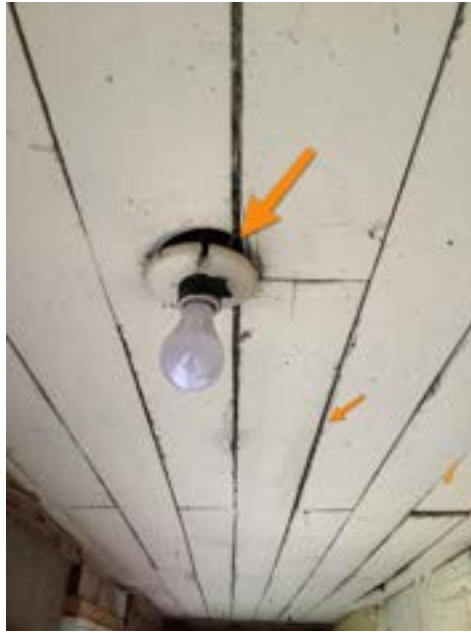
- Between the eave panels on **all** sides of the home, to include the enclosed porch; please note, several panels are missing (Pictures 1a, 1b)
- Between the fascia and eaves on **all** sides of the home; please note, the fascia and eaves appear to be warped from moisture intrusion (Picture 2)

This can create a point for possible moisture intrusion, pest infestation, as well as deterioration of the surrounding material, if not addressed. We recommend a licensed roofing contractor assess and repair as needed to prevent.

Picture 1b - Eave Panel Gaps (Representative Picture)

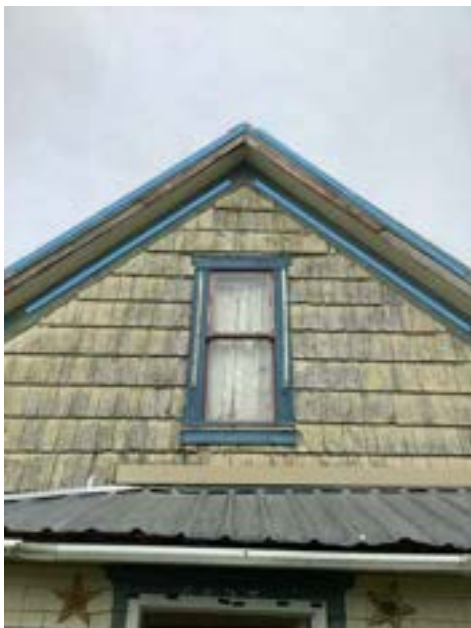
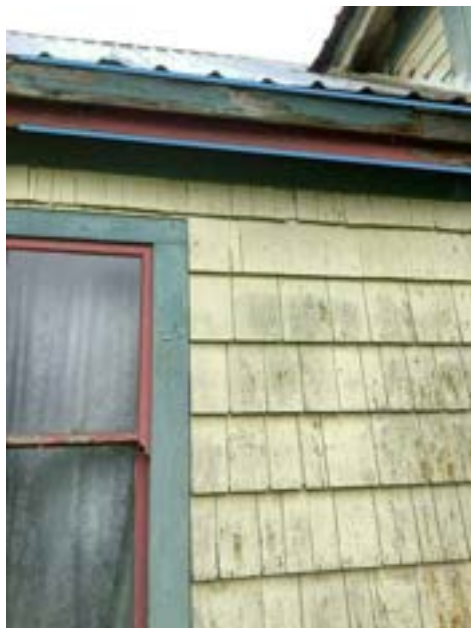
The paint is deteriorating on the fascia **and** eaves on **all** sides of the home. Deterioration of the paint exposes the underlying material and structure to the external elements and could lead to possible moisture intrusion. To protect and extend the life of the material we recommend these areas be prepped and painted by a licensed painting contractor.

Fascia/Eave Paint Deteriorating (Representative Picture)

Contact a qualified painting contractor.

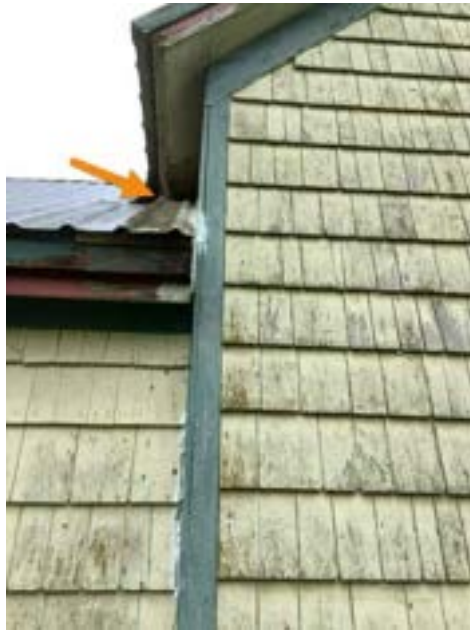
Portions of the fascia boards are in contact with the roof. Fascia that is in direct contact with the roof can absorb the moisture from the roof surface, leading to deterioration of the material. It is recommended that a minimum of 1.5 inches of space be between the fascia and the roof surface to allow for proper water drainage off the roof surface without damaging the material. We recommend assessment and possible repair by a licensed roofing contractor.

Fascia in Contact With the Roof
(Representative Picture)

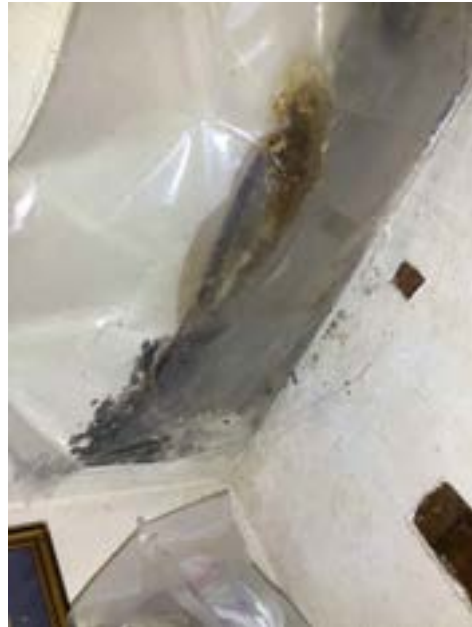
Signs of An Active Leak - Bedroom (First Floor - On Right)

Contact a qualified roofing professional.

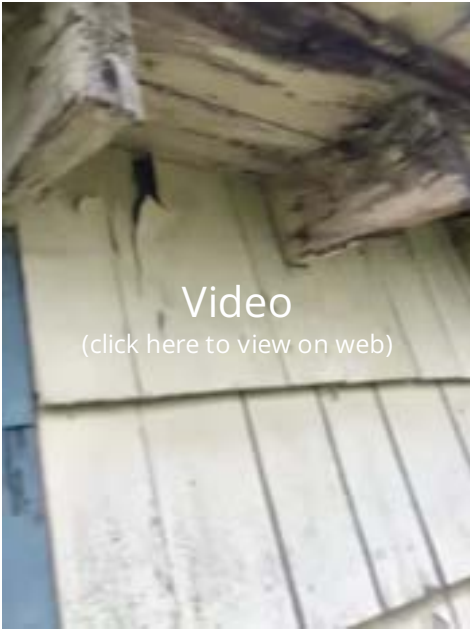
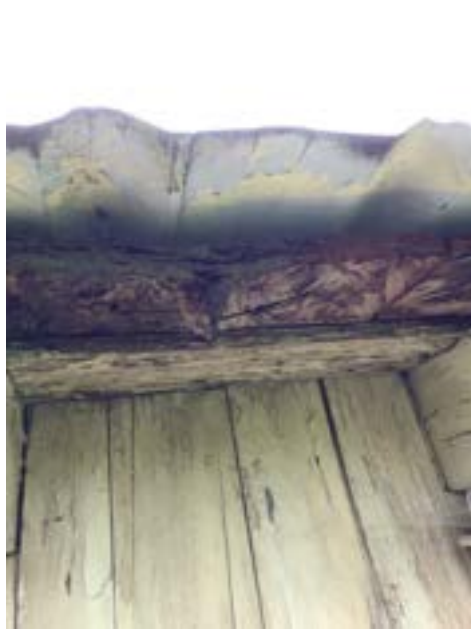
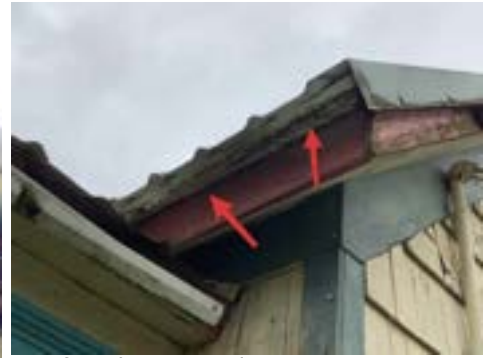
Roof Decking Wood Rot
(Representative Picture)

Contact a qualified roofing professional.

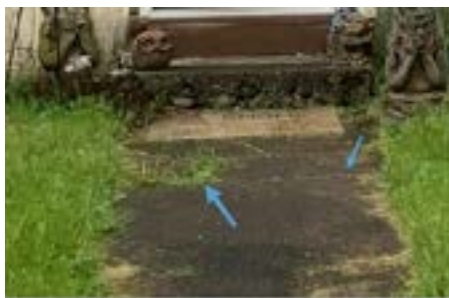
Crack(s) were observed in the walkway on the front side (Side A) of the home, which may indicate movement in the underlying soil. This is common for the age of the home, and can occur as the material ages, lack of maintenance or cleaning, in conjunction with continued exposure to the elements. We recommend monitoring to ensure the cracks do not worsen; if the condition worsens, we recommend a licensed concrete contractor assess for possible repairs.

Walkway Crack(s) - Side A
(Representative Picture)

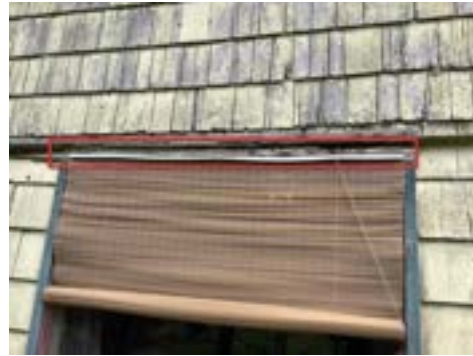
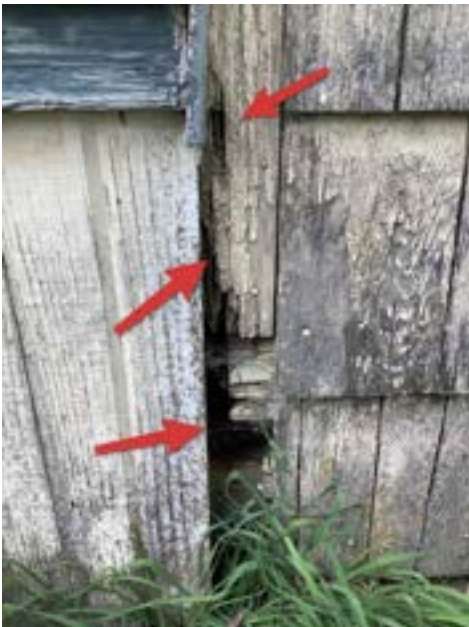
Siding/Trim Wood Rot (Representative Picture)

Contact a qualified siding specialist.

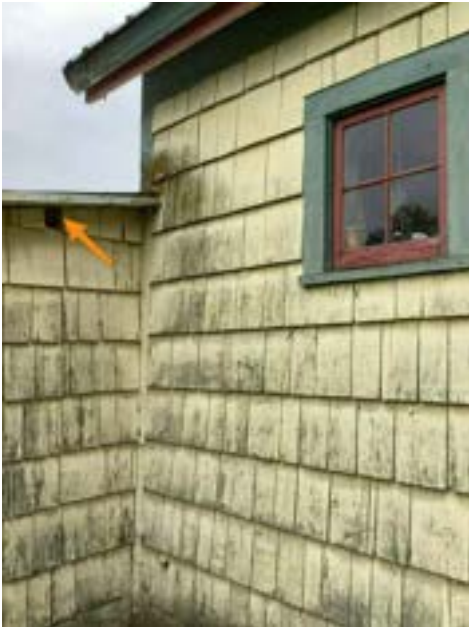
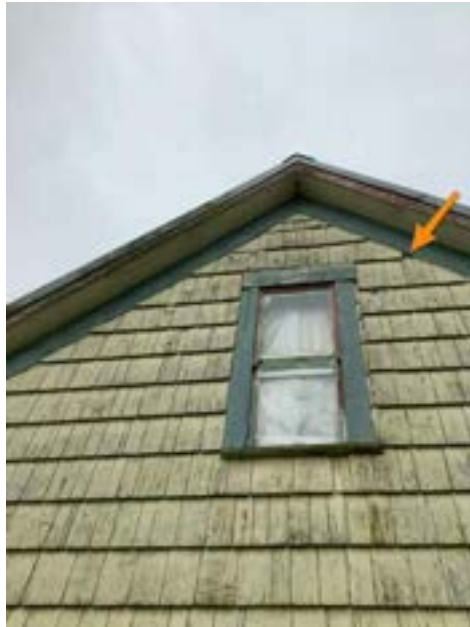
Section(s) of Missing Siding
(Representative Picture)

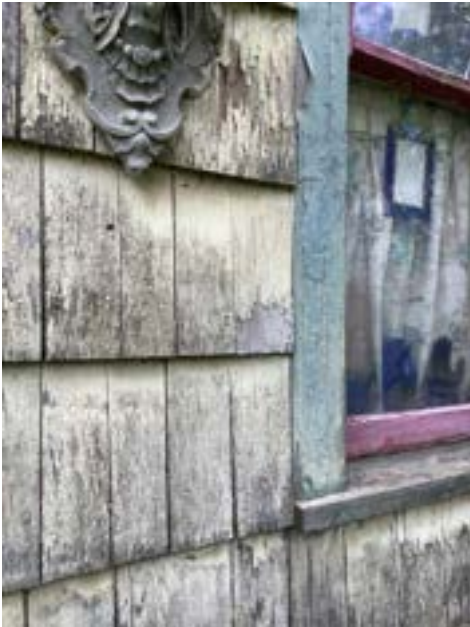
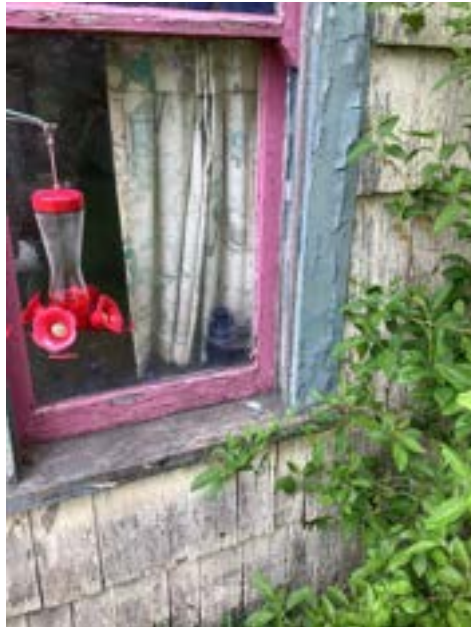
Siding/Trim Paint Deteriorating (Representative Picture)

Contact a qualified painting contractor.

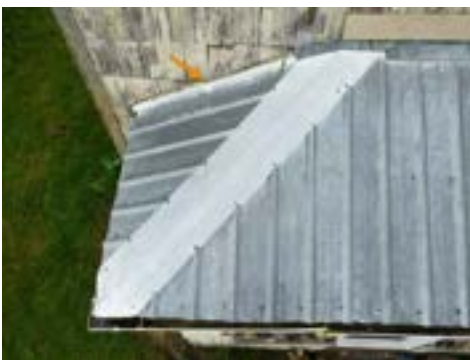
Siding in Contact With Roof (Representative Picture)

Contact a qualified siding specialist.

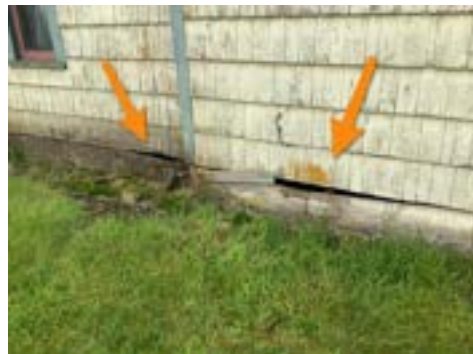
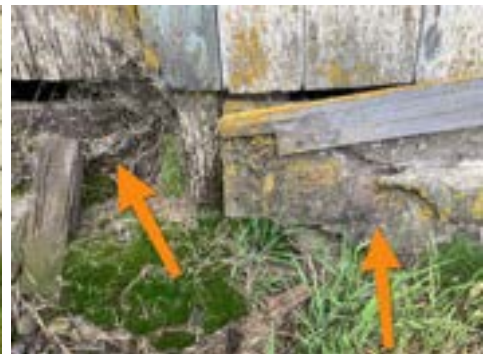
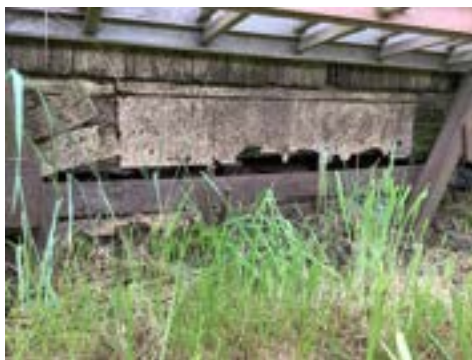
Skirting Wood Rot (Representative Picture)

Contact a qualified general contractor.

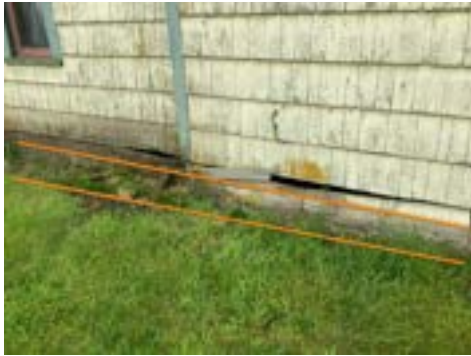
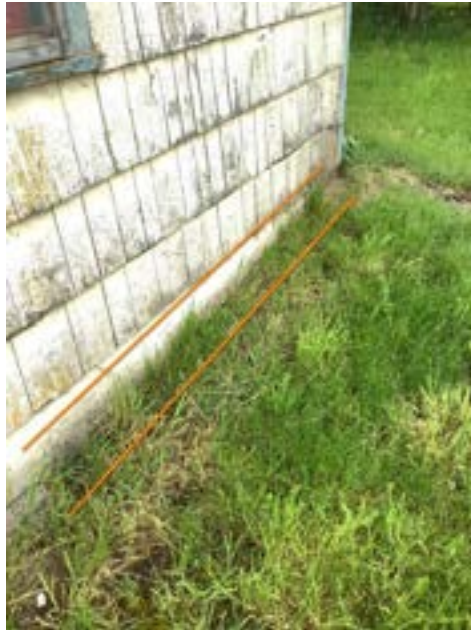
Skirting in Contact With the Ground
(Representative Picture)

Contact a qualified general contractor.

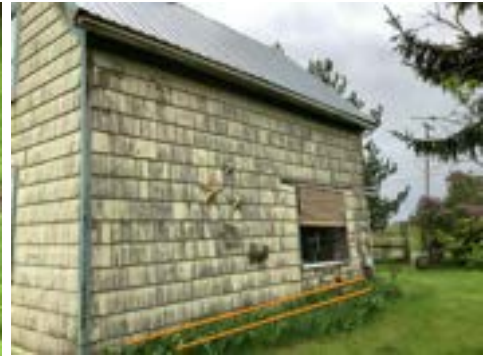
Skirting in Contact With the Ground
(Representative Picture)

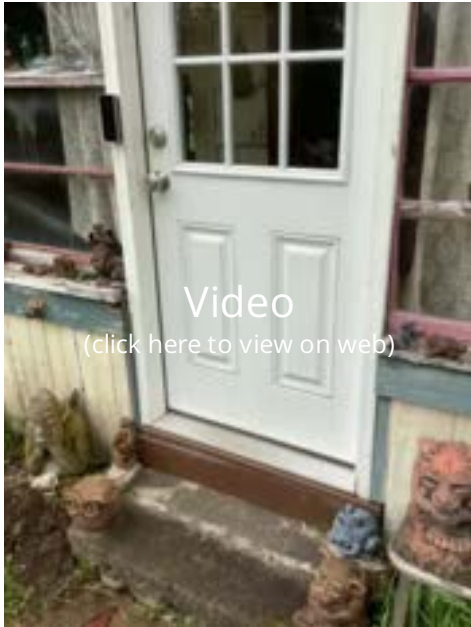
Significant wood rot was identified in the window trim **and** frames on **all** sides of the home. The wood rot was deemed significant due to the extent of deterioration of the material, which has resulted in several loose windowpanes, and caused several panes to fall out of the frames. We recommend a licensed window contractor assess and repair as needed to prevent further deterioration of the trim/frames, and further damage to the glass panes.

****Note: The Video Depicts the Window Trim/Frame Wood Rot.****

Contact a qualified window repair/installation contractor.

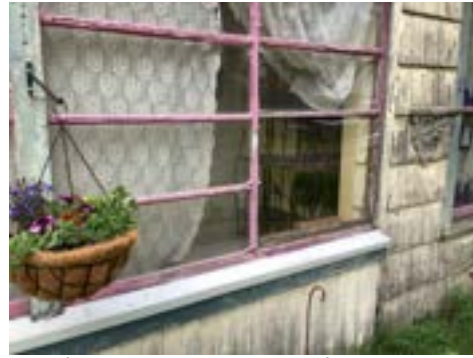
Window Trim/Frame Wood Rot
(Representative Picture)

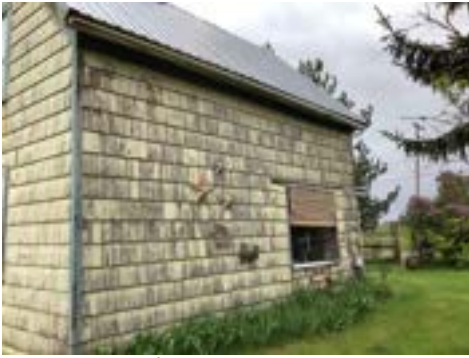
Picture 1 - Side A

- Front Side of the Home (Side A) (Picture 1)
- Right Side of the Home (Side B) (Picture 2)
- Back Side of the Home (Side C) (Picture 3)

The single biggest issue in regard to plant material growing near or on the structure of the home is the presence of moisture, which can accelerate the deterioration of the siding/exterior cladding and create a possible avenue for pests to enter the home. Additionally, larger shrubs and/or trees growing near the foundation can cause instability of the structural integrity of the foundation, as the root systems continue to grow and disturb the supporting soil around the foundation structure.

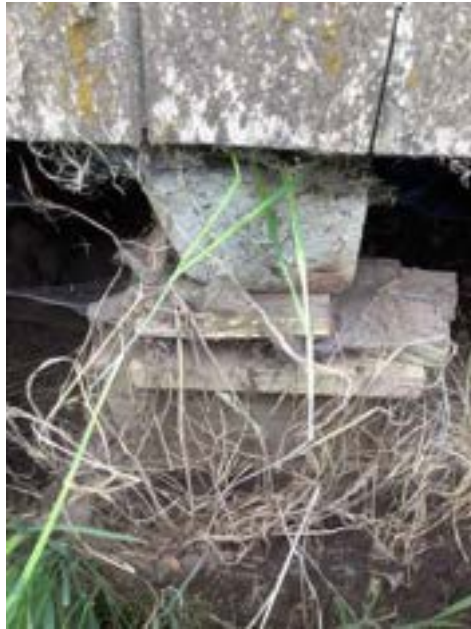
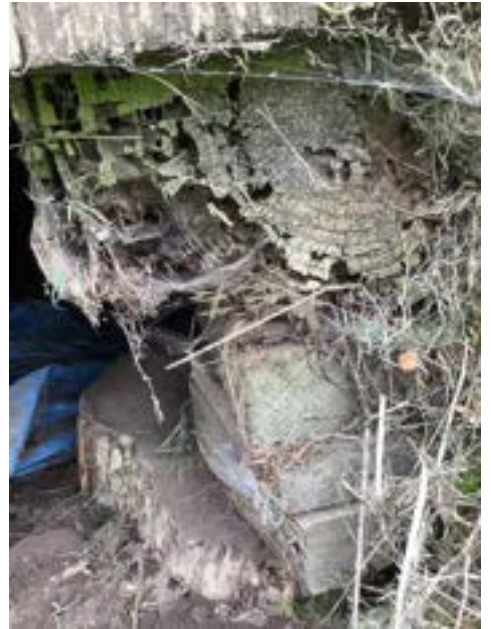
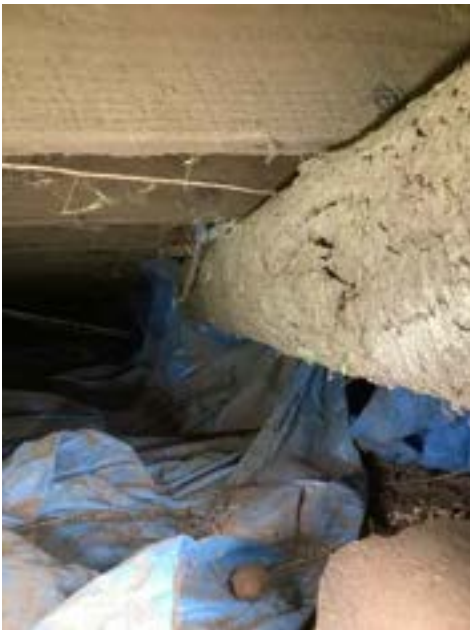
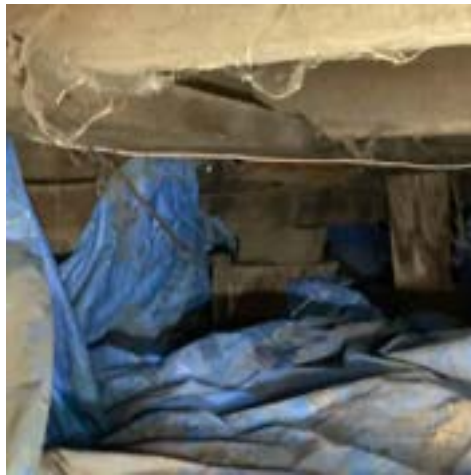
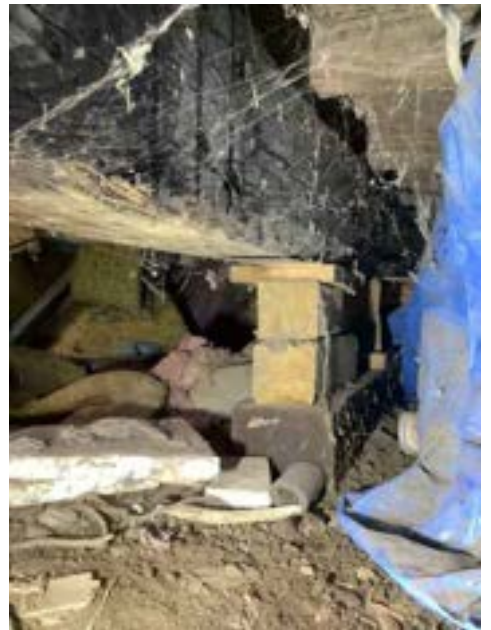
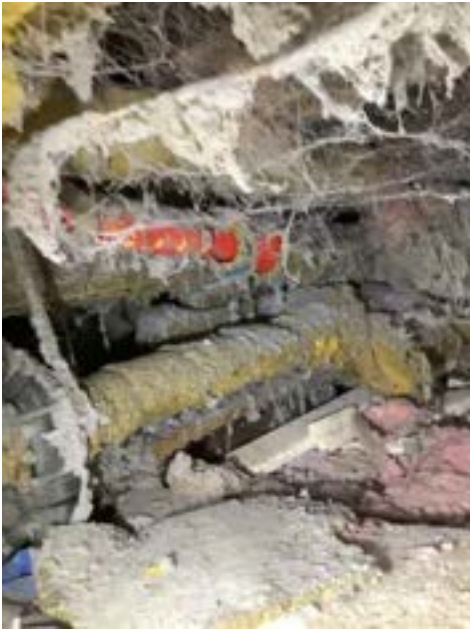
Due to the presence of obstructions and possible instability of the sub-floor structure within the crawl space, there was limited ability to fully assess the underlying portions of the structures, the sub-floor structure (framing), and portions of the plumbing, HVAC ductwork, and other components/systems that are present.

Limitations/Obstructions - Crawl Space (Representative Picture)

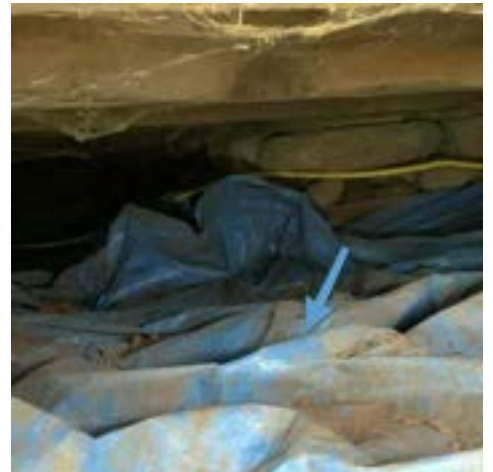
An incorrect type of vapor barrier has been used on the floor of the crawl space; the material appears to be that of a general tarp. It is recommended that 6-mil thick polyethylene plastic, with 12 inches of overlap is present on each seam of the vapor barrier to prevent moisture intrusion, which can seep from the ground into the crawl space. If left unaddressed, excessive moisture in the crawlspace can cause corrosion to ductwork, wood rot to the framing members, and possibly create an environment suitable for the development of microbial growth, such as mold. As such, we recommend a licensed insulation contractor assess and correct.

Incorrect Type of Vapor Barrier Material
- Crawl Space (Representative Picture)

Contact a qualified insulation contractor.

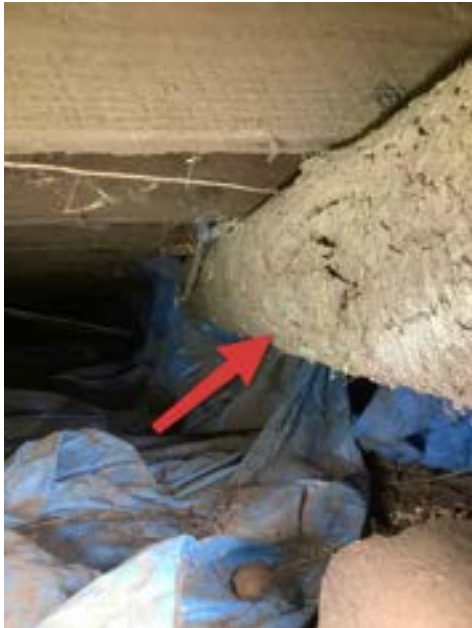
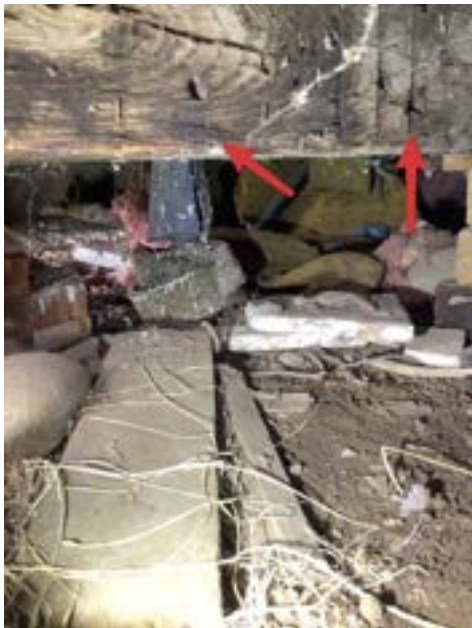
Significant wood and damage to the sub-floor structure was observed in the crawl space. The support beams and wood/stone columns are deteriorating. Over time and if left unaddressed, the deterioration could become more extensive, leading to instability of the sub-floor structure and the associated framing members. We recommend a structural engineer further evaluate.

Sub-Floor Structure Wood Rot/Damage - Crawl Space (Representative Picture)

Contact a qualified structural engineer.

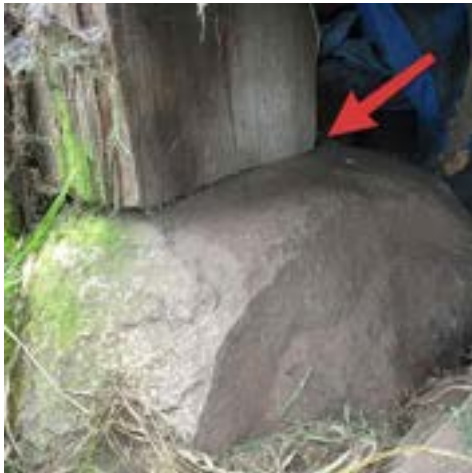
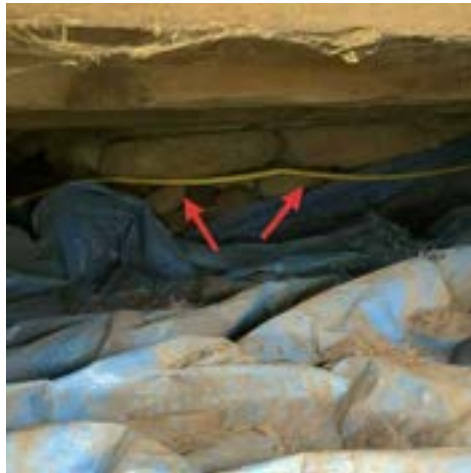
The sub-floor structure is improperly braced in multiple areas in the observable portions of the crawl space. The support columns appear to be stacked scrap wood and/or stone, and are unstable and not adequately supporting the floor beam. We recommend further evaluation by a structural engineer assess and repair as needed to ensure stability of the columns and the overhead sub-floor structure.

Floor Structure Improperly Braced - Crawl Space (Representative Picture)

Contact a qualified structural engineer.

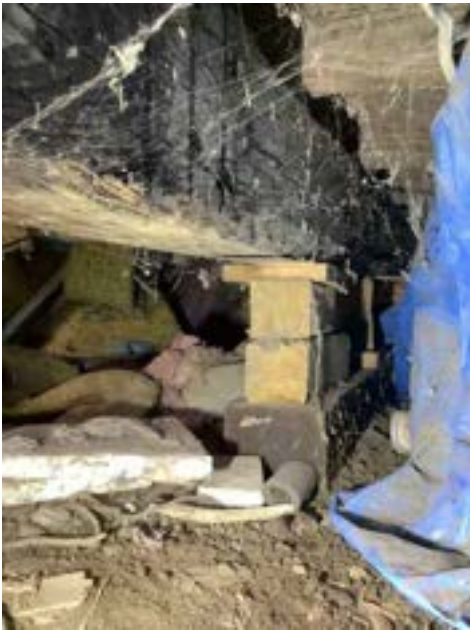
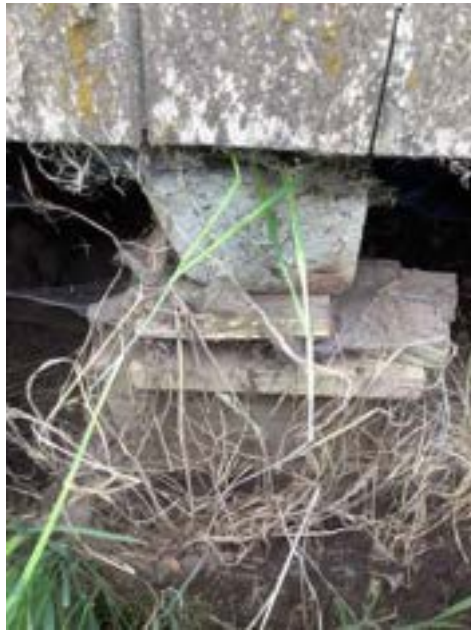
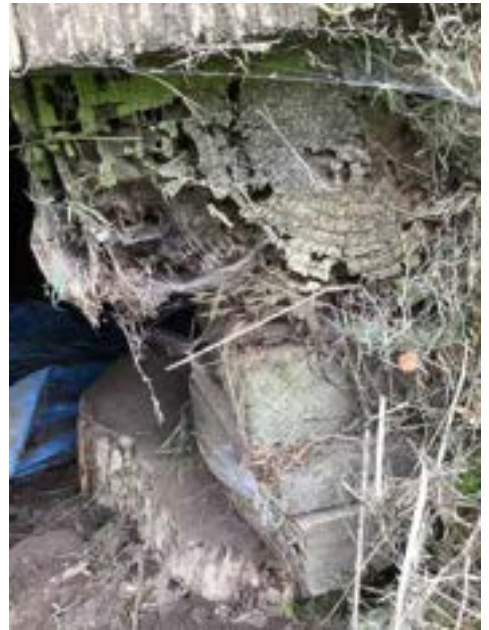
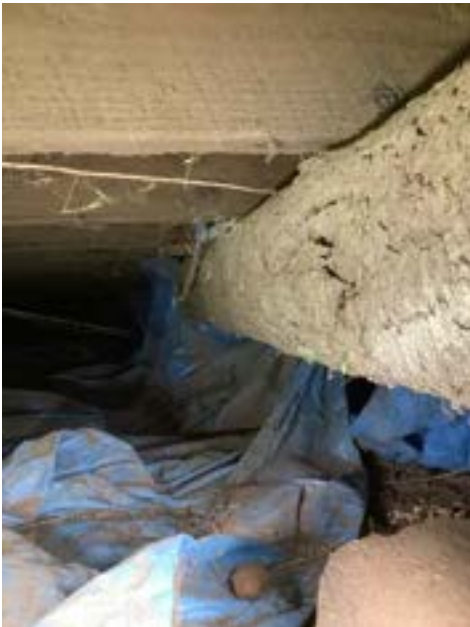
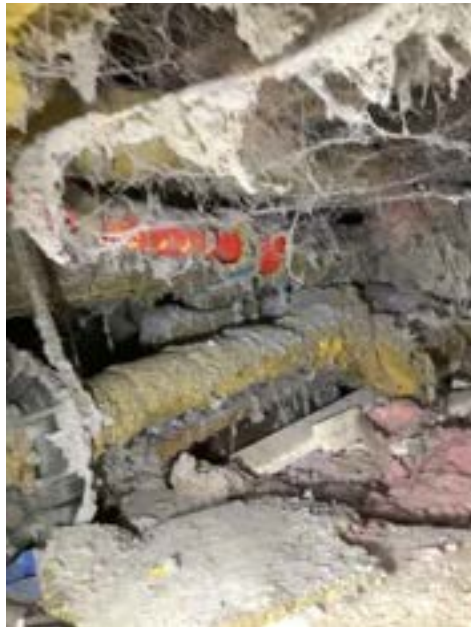
Due to the presence of obstructions and possible instability of the sub-floor structure within the crawl space the inspector was unable to evaluate the condition of the water supply distribution lines, determine if leaks are present, and/or inspect the associated systems and components.

Limitations/Obstructions - Crawl Space (Representative Picture)

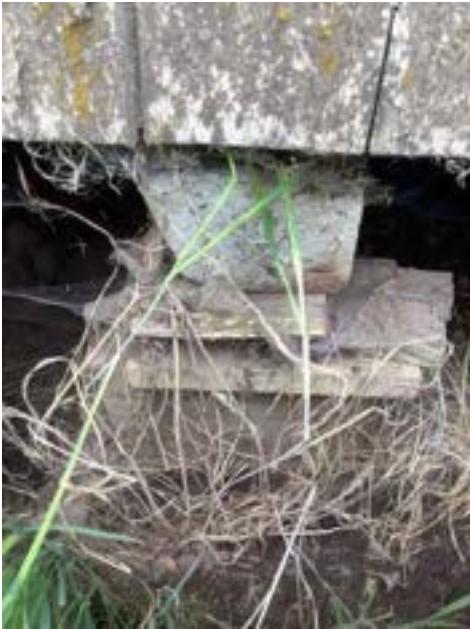
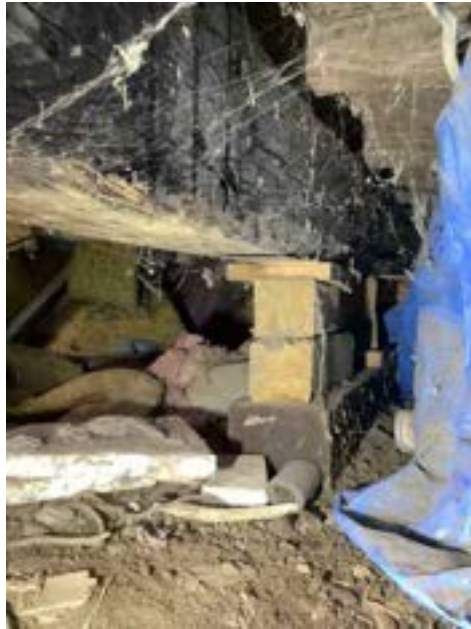
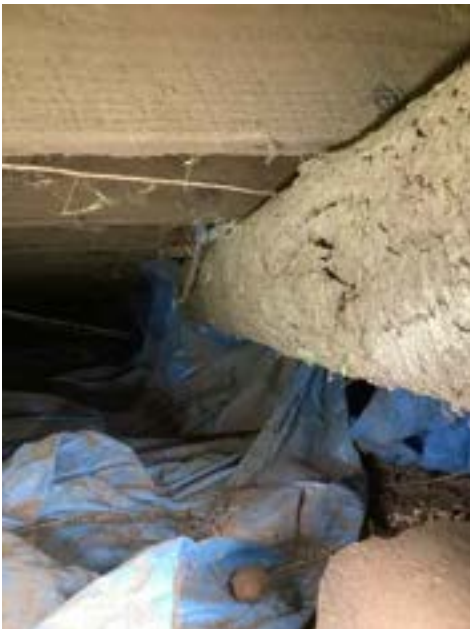
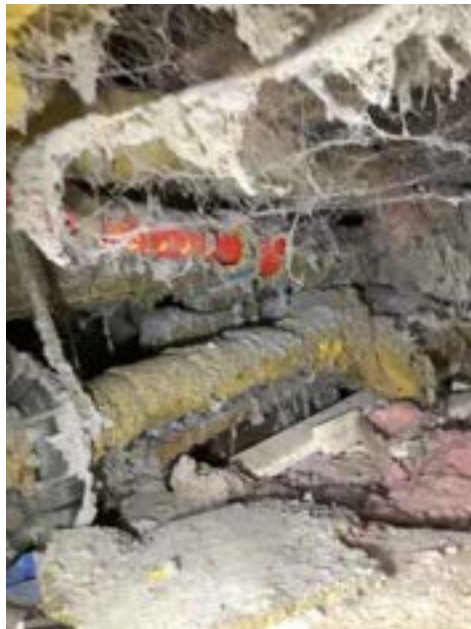
Additionally, due to the presence of obstructions and possible instability of the sub-floor structure within the crawl space the inspector was unable to evaluate the condition of the drain/waste piping, determine if leaks are present, and/or inspect the associated systems and components.

Limitations/Obstructions - Crawl Space (Representative Picture)

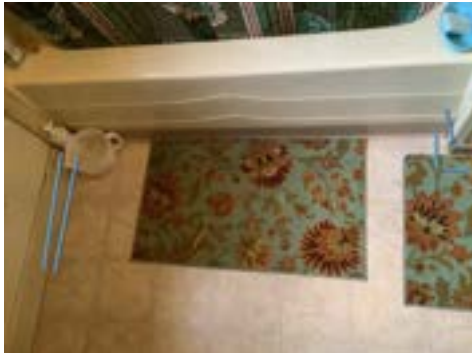
Picture 1 - Full Bathroom (First Floor)

The sealant is deteriorating and/or missing around the bathtub/shower in the first floor full bathroom, observed in the following areas:

The absence of sealant can allow for moisture intrusion between the walls and floor, and possible deterioration of the underlying material and/or structure. We recommend a knowledgeable/skilled individual assess and correct as needed to prevent moisture intrusion.

Contact a handyman or DIY project

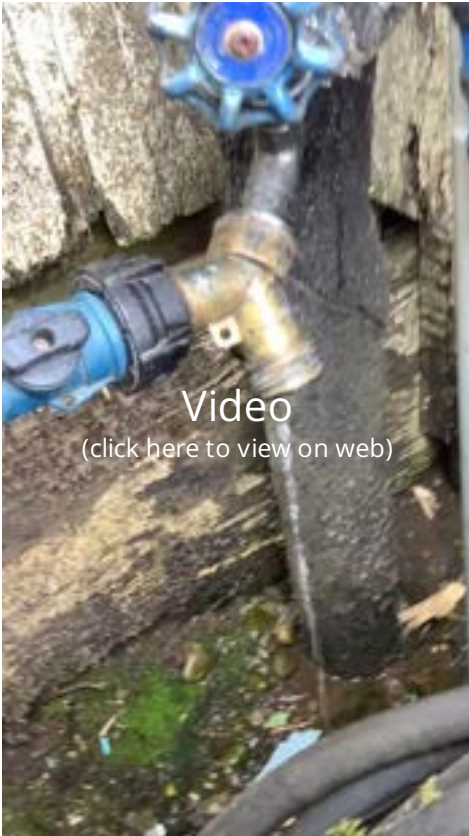
The water spigot located near the transition corner from the front to left side (Corner A/D) of the home appears to be leaking at the valve (control knob), when the spigot is in use and when the valve is closed. If left unaddressed, this could result in damage to the exterior siding and/or possibly a pipe break in extreme cold weather conditions. We recommend a licensed plumber assess and repair as necessary.

****Note: The Video Depicts the Leaking Exterior Water Spigot.****

Contact a qualified plumbing contractor.

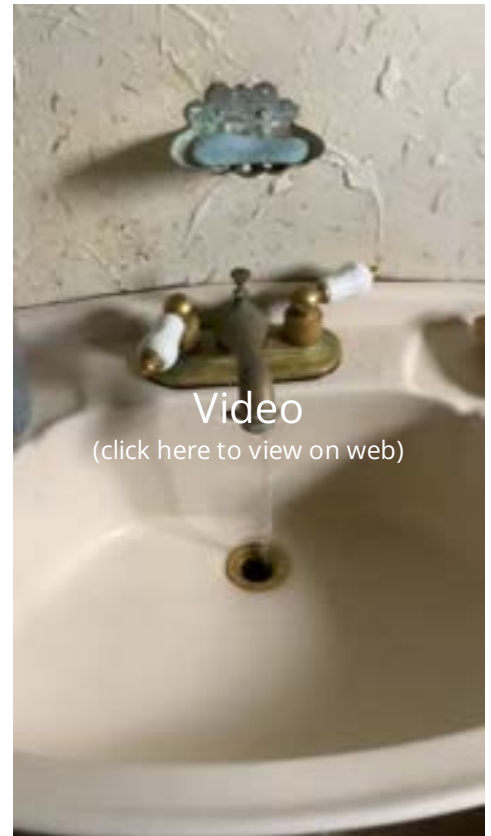
At the time of inspection, low water pressure was observed from the sink faucet in the first floor full bathroom; please note, this occurred during assessment of **both** the hot water and cold water functions. Over time, the water pressure could continue to decrease, and further impact the functions of the fixture. We recommend a licensed plumbing contractor further evaluate and repair as necessary.

Contact a qualified plumbing contractor.

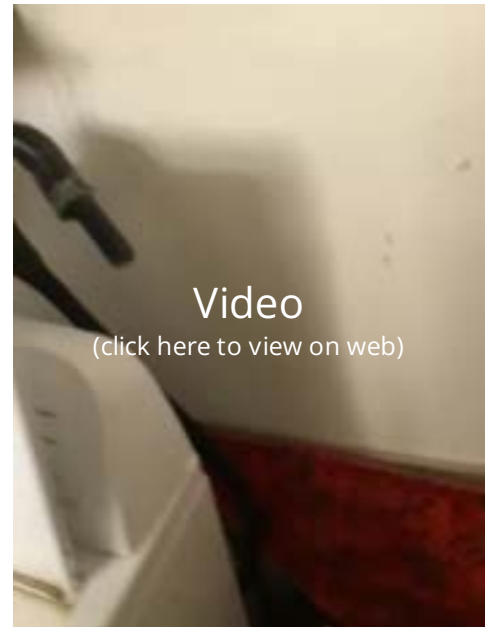
The drain piping for the washing machine has collapsed and per the tenant is no longer useable; please note, this section of the piping is located within the slab floor. A make-shift drain system has been set-up to expel the wastewater when the washing machine is in use. We recommend further evaluation and repair by a licensed plumbing contractor to ensure the washing machine is draining to the appropriate drain connection.

Contact a qualified plumbing contractor.

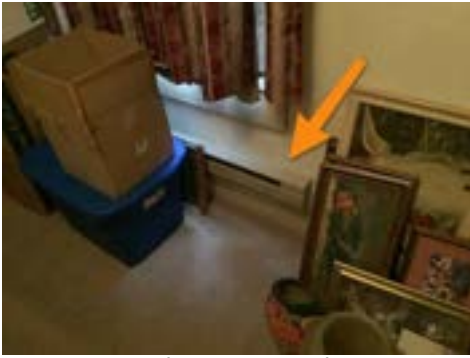
Picture 1 - Bedroom (First Floor - On Left)

At the time of the inspection, several electric baseboard heaters and wall heaters were blocked with obstructions, noted in the following locations:

As such, the inspector was unable to operate the heaters in these locations, determine if they are properly functioning, and identify any issues that may be present. We recommend removal of the obstructions and a re-inspection by a qualified individual to ensure proper function and operability of the units.

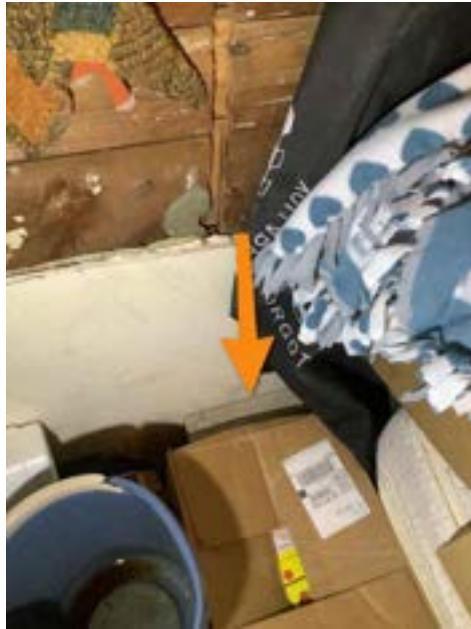
Picture 2 - Bedroom (First Floor - On Right)

- a). The electric baseboard heater on the back side wall (Picture 2)

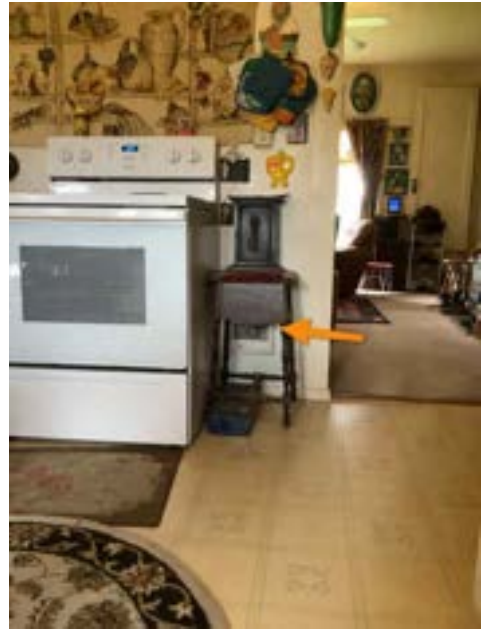
Picture 3 - Kitchen (First Floor)

- a). The electric wall heater on the left side wall (Picture 3)
