8527 STAYTON RD

TURNER, OR

**Oregon
Farm & Home**
★ BROKERS ★

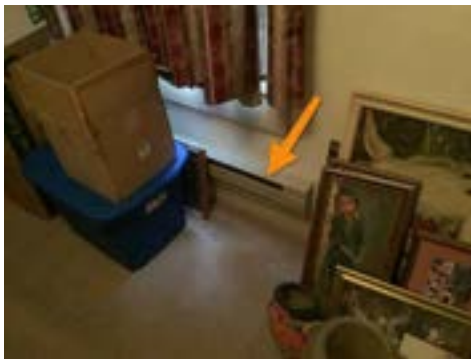
Picture 1 - Bedroom (First Floor - On Left)

At the time of the inspection, several electric baseboard heaters and wall heaters were blocked with obstructions, noted in the following locations:

As such, the inspector was unable to assess the thermostat functions for these heaters, determine if they are properly functioning, and identify any issues that may be present. We recommend removal of the obstructions and a re-inspection of the thermostats by a qualified individual.

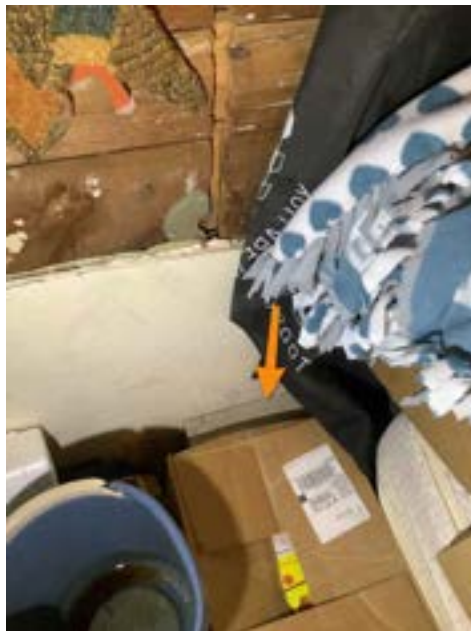
Picture 2 - Bedroom (First Floor - On Right)

- a). The electric baseboard heater on the back side wall (Picture 2)

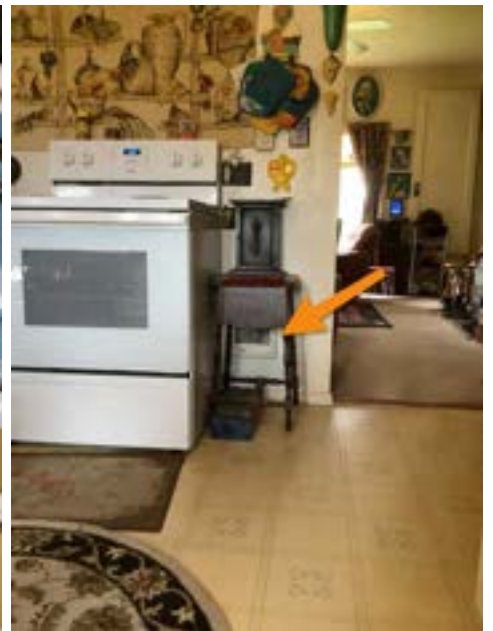
Picture 3 - Kitchen (First Floor)

- a). The electric wall heater on the left side wall (Picture 3)

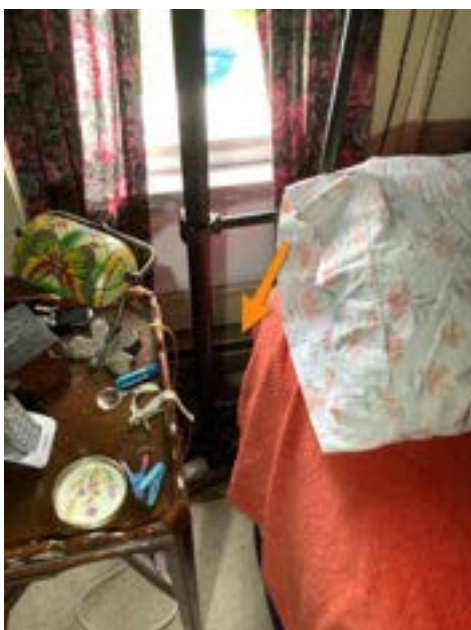
Picture 4 - Bedroom (Second Floor)

- a). The electric baseboard heater on the right side wall (Picture 4)

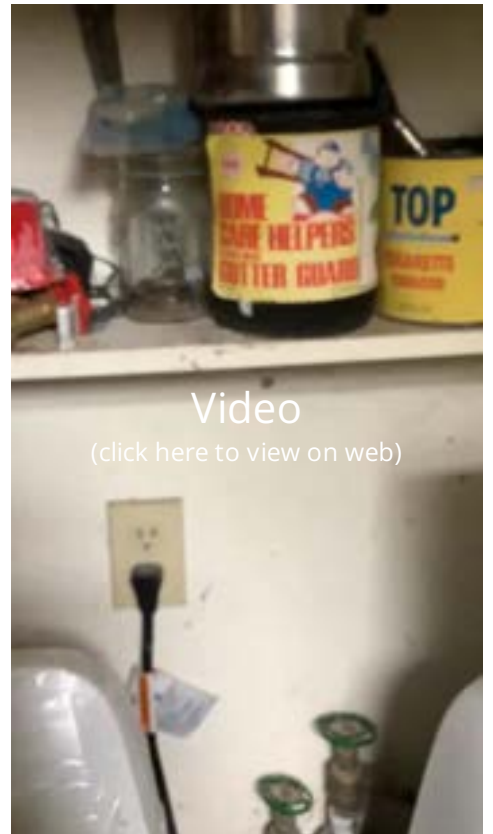
There is no GFCI protection present on the outlet behind the washing machine in the first floor utility room. It is recommended that all exterior outlets and outlets within 6 feet of water sources have GFCI protection to prevent possible electric shock or electrocution. We recommend a knowledgeable/skilled individual upgrade by installing ground fault receptacles in all locations near water sources.

Contact a handyman or DIY project

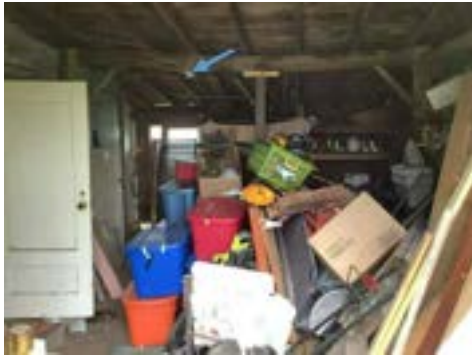
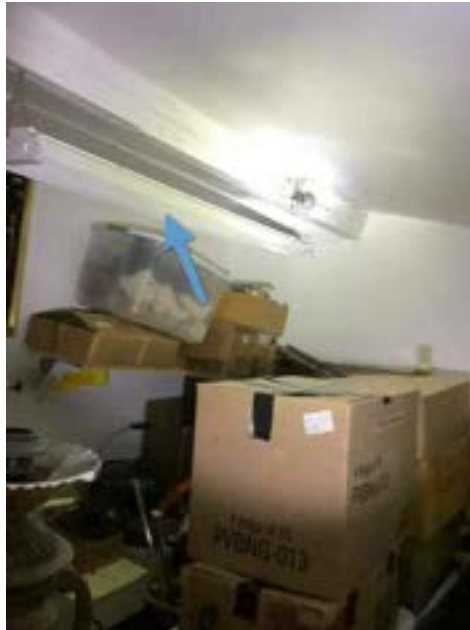
Several bulbs were missing from the light fixtures in the garage, at the time of the inspection. This could be due to a burned out/expired bulb that needs replacing; however, if the problem persists, we recommend assessment and repair by a licensed electrical contractor.

Light Bulb(s) Not Present - Garage (Representative Picture)

Contact a handyman or DIY project

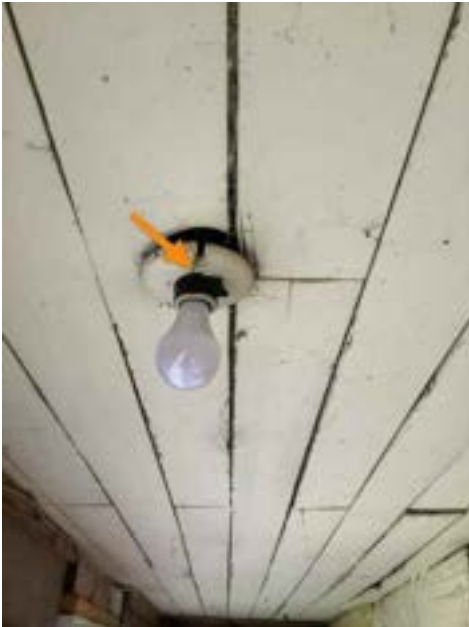
Light Fixture Damaged - Side A

Contact a handyman or DIY project

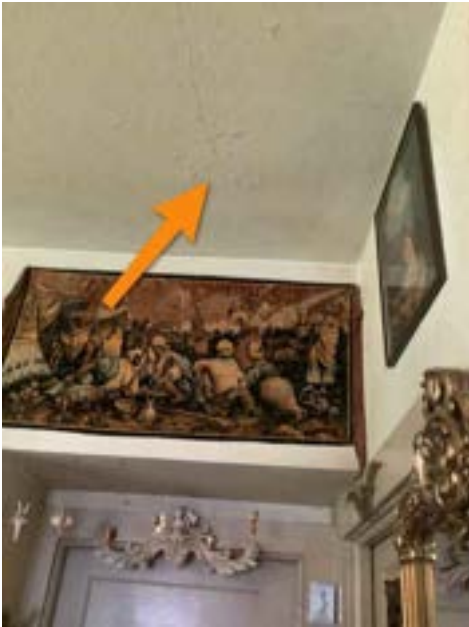
Smoke Detector(s) Not Present - First Floor (Representative Picture)

Contact a handyman or DIY project

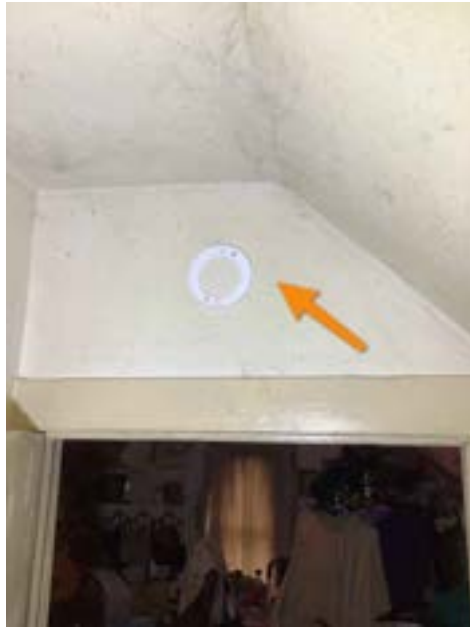
Smoke Detector(s) Not Present - Second Floor (Representative Picture)

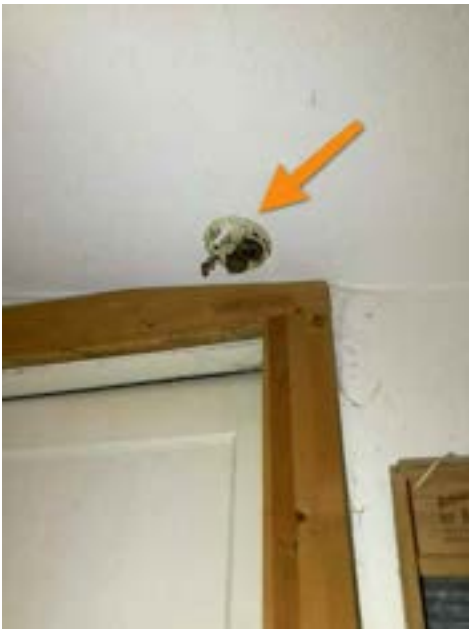
Smoke Detector(s) Damaged (Representative Picture)

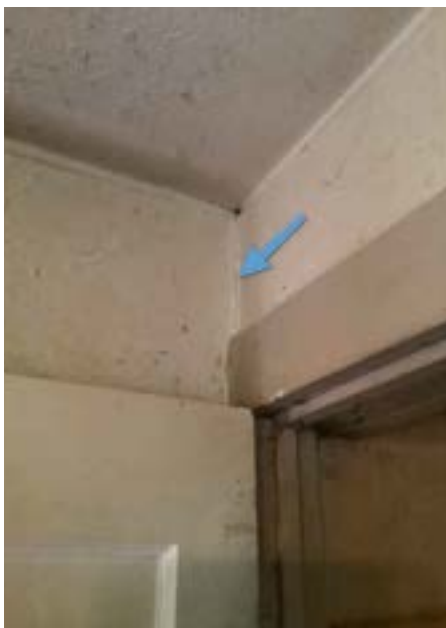
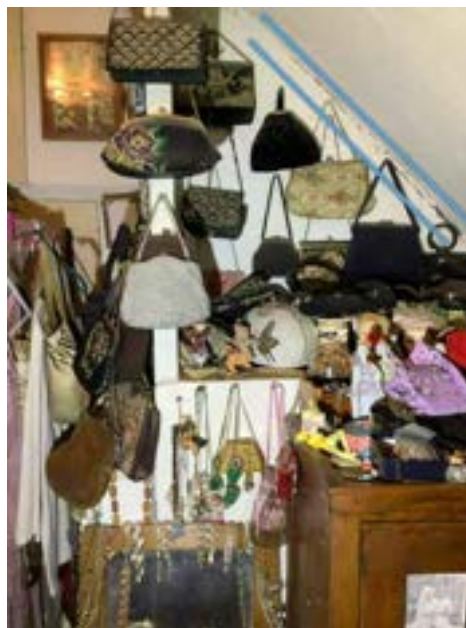
Minor cracks were observed in the wall surfaces, in various areas, throughout the home. Cracks of this nature can be due to settling of the home, in conjunction with temperature changes, resulting in contraction and expansion of the structure, or improper installation of the materials. We recommend monitoring, and if the cracks or condition worsens, contact a licensed drywall contractor for assessment and repairs.

Wall Surface Crack(s) (Representative Picture)

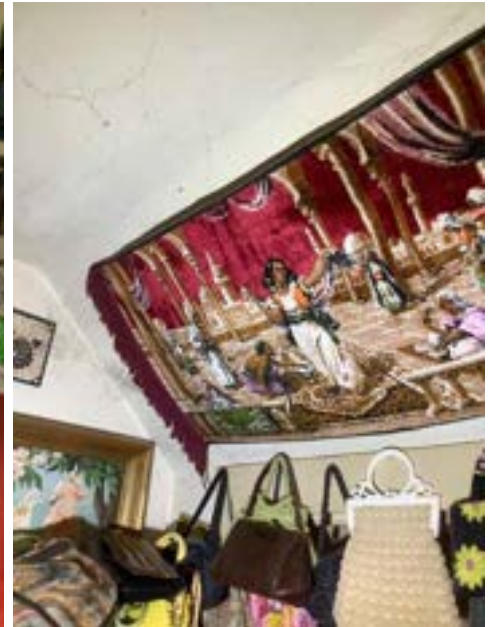
Limitations/Obstructions - Interior (Representative Picture)

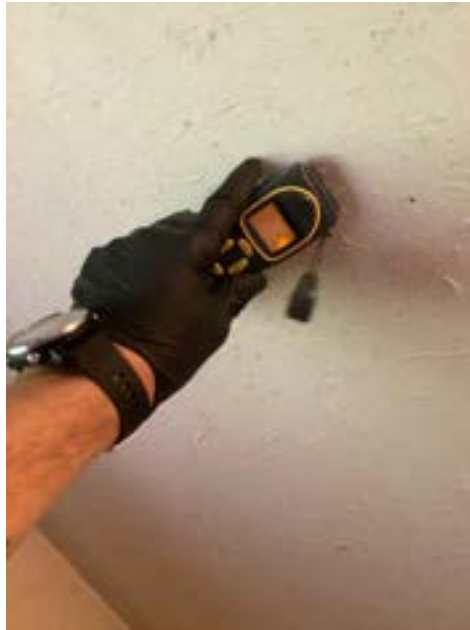
Staining/discoloration was observed on ceiling in the first floor full bathroom; moisture readings indicate a 0% saturation level at the time of the inspection. While the staining/discoloration appears to be surface level at this time, this could be associated with the lack of an exhaust fan and the accumulation of condensation. We recommend further evaluation by a licensed contractor.

Ceiling Surface Staining/Discoloration - Full Bathroom (First Floor)

Contact a qualified general contractor.

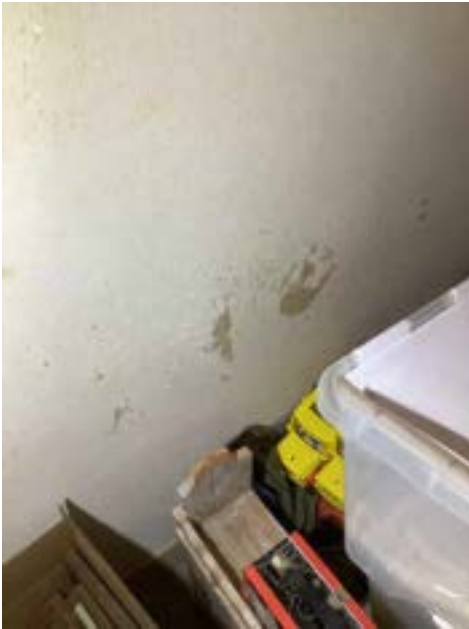
Minor damage to the wall surfaces was observed in various areas throughout the home. The drywall/plaster material is exposed and if left unaddressed, this could lead to further damage and/or deterioration of the wall surfaces. We recommend a knowledgeable/skilled individual patch/repair the damage, and the wall surfaces be finished to match the existing wall surfaces.

Wall Surface Damage (Representative Picture)

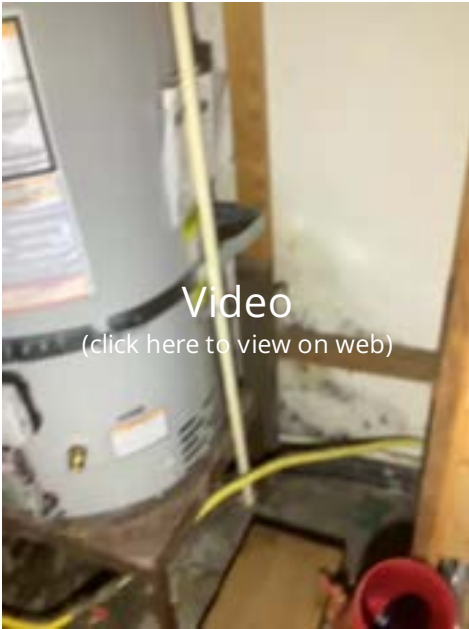
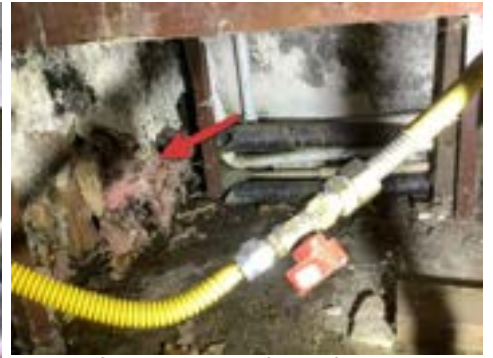
Staining/discoloration associated with moisture intrusion was observed on the front side and right side walls in the first floor utility room; additionally, wood rot was identified in the framing members along the lower portions of the walls. Moisture readings indicate a 50% saturation level at the time of the time of the inspection. If left unaddressed, this could lead to further deterioration of the wall and interior framing structure, possibly causing instability of the wall structures. We recommend a licensed contractor further evaluate and repair as needed.

Signs of an Active Leak - Utility Room (First Floor)

Contact a qualified general contractor.

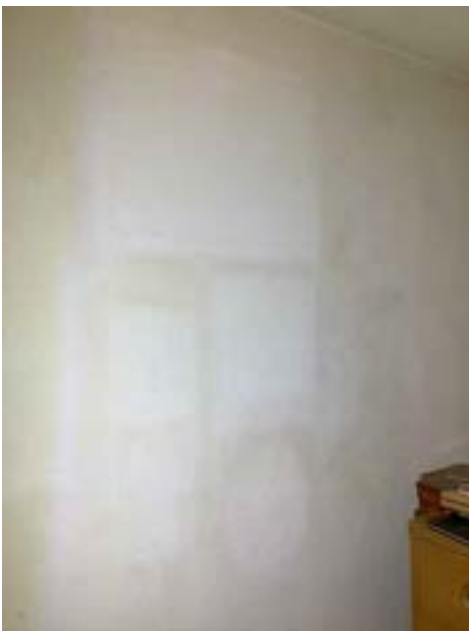
Staining/discoloration is present on the wall surfaces in various areas throughout the home; this appears to be ghosting associated with dust and/or smoke. We recommend a knowledgeable/skilled individual assess and clean, prep, and paint the wall surfaces.

Staining/Discoloration on Wall Surface(s) (Representative Picture)

Contact a handyman or DIY project

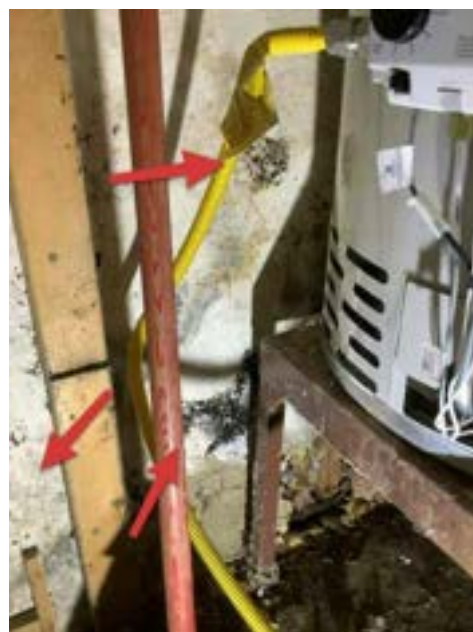
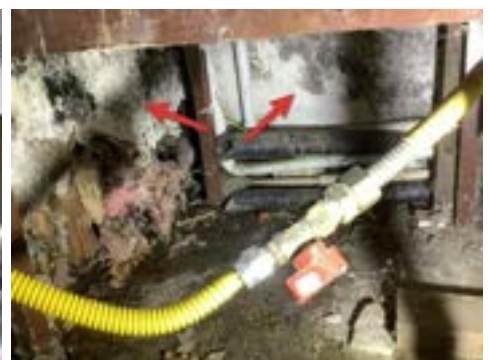
Staining/discoloration was observed on the wall surfaces in the first floor utility room, indicating the possible presence of microbial growth. As microbial growth can appear as a discoloration, staining, or fuzzy growth on the surface of building materials and furnishings, we recommend that the area is assessed and tested by a licensed mold contractor to ensure that no forms of microbial growth, such as mold, are present.

Signs of Possible Microbial Growth - Utility Room (First Floor)

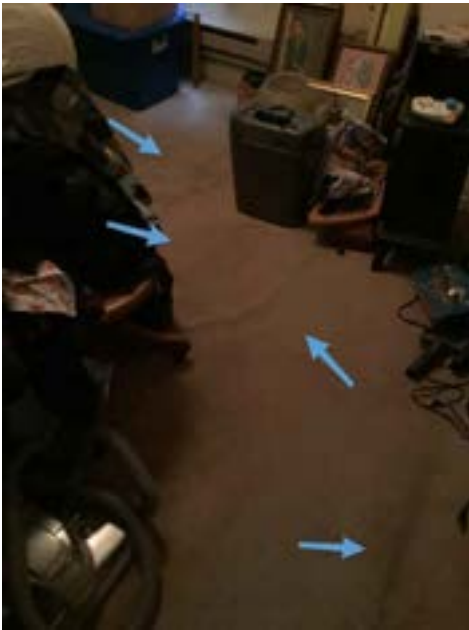
The carpet appears to be loose, in various areas, throughout the home. This commonly occurs when the carpet comes loose from the tack-less strips, or if the tack-less strips come loose from the floor. Once loose, the carpet is no longer taut and wrinkling can occur over time, which can create a potential trip hazard, and possible deterioration of the material. We recommend assessment and repair by a licensed flooring contractor.

Loose Carpet (Representative Picture)

Contact a qualified flooring contractor

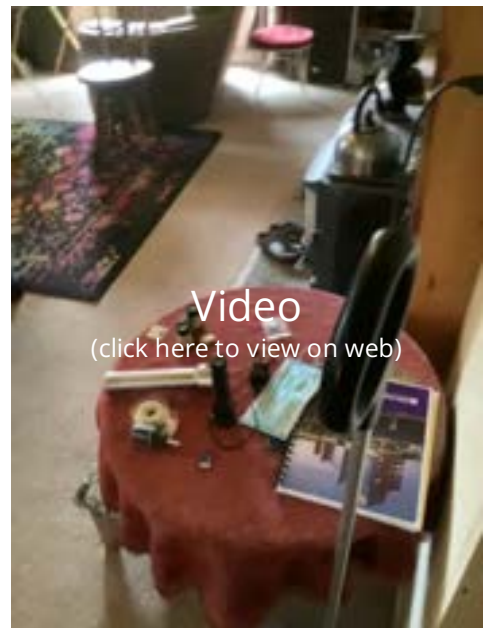
The flooring appears to be uneven throughout the first floor, sloping towards the back/right side of the home. This could be due to an improperly braced floor structure, improper installation of the flooring, and/or significant settling of the home. If left unaddressed, this could pose a safety hazard and lead to deterioration of the flooring. We recommend a structural engineer assess and repair as needed.

Contact a qualified structural engineer.

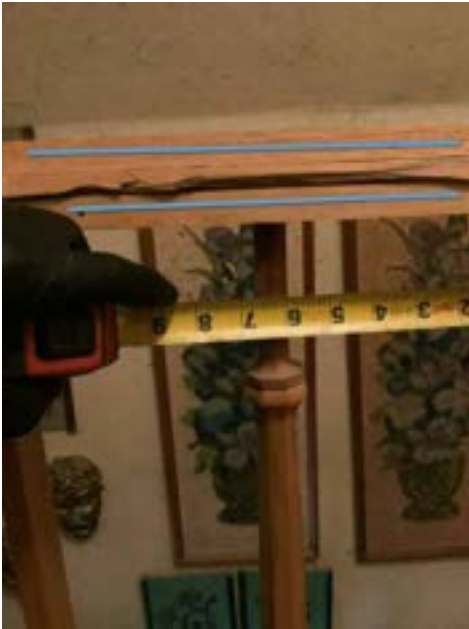
Guardrail Damaged - Hallway (Second Floor)

Contact a handyman or DIY project

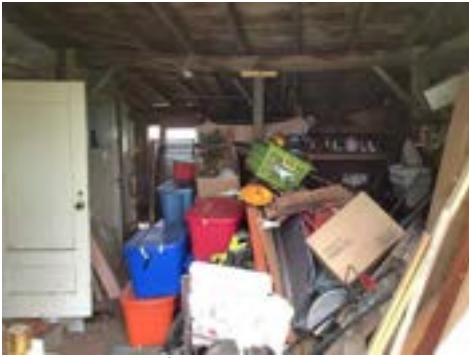
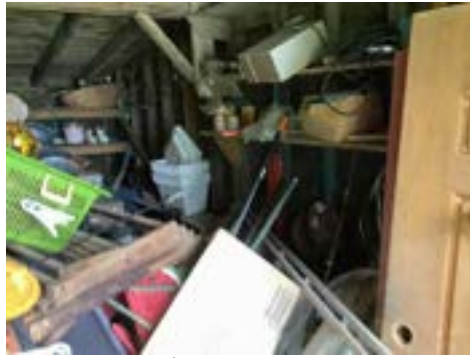
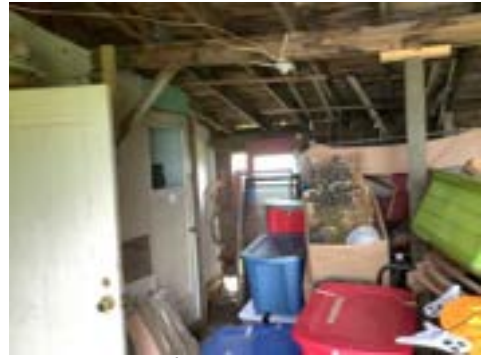
Due to various obstructions in the garage, the inspector was unable to fully assess the garage in its entirety. These obstructions limited the inspector's ability to fully evaluate the ceiling, wall surfaces, and flooring, which include access to outlets and other systems, to verify proper function and operability. We recommend a re-inspection when the garage is emptied to facilitate a complete assessment.

Limitations/Obstructions - Garage

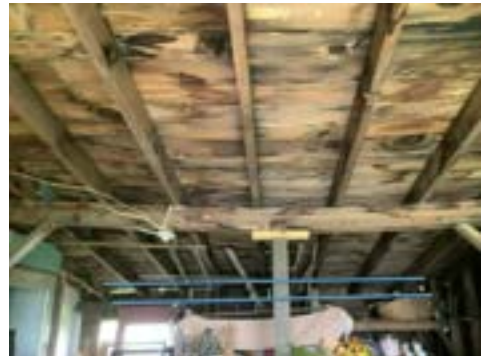
Ceiling Structure Gaps - Garage (Representative Picture)

Contact a qualified general contractor.

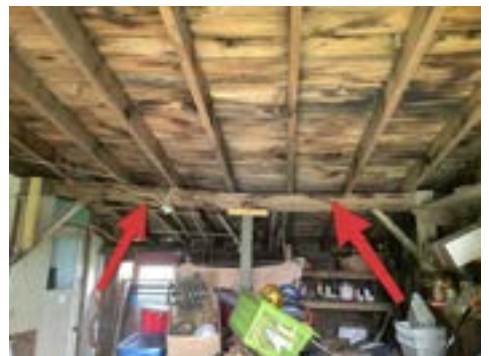
Ceiling Structure Sagging - Garage

Contact a qualified general contractor.

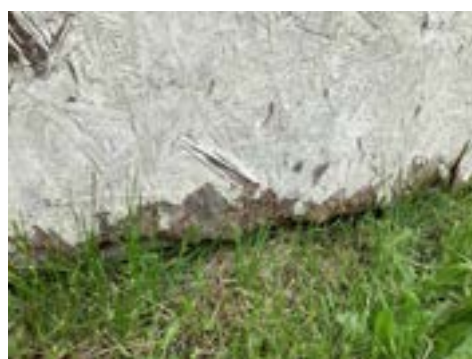
Garage Door Wood Rot - Side B (Representative Picture)

Contact a qualified garage door contractor.

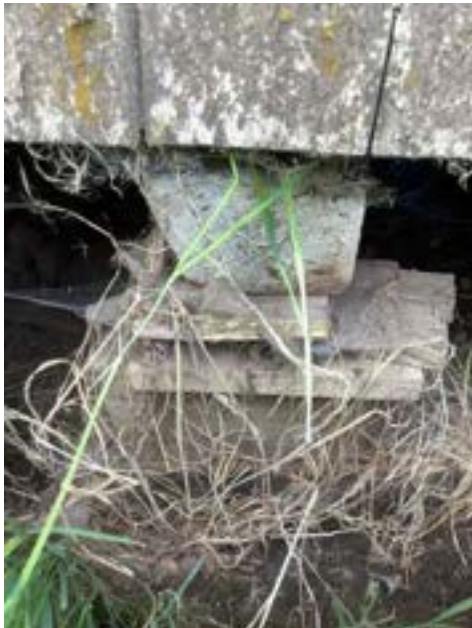
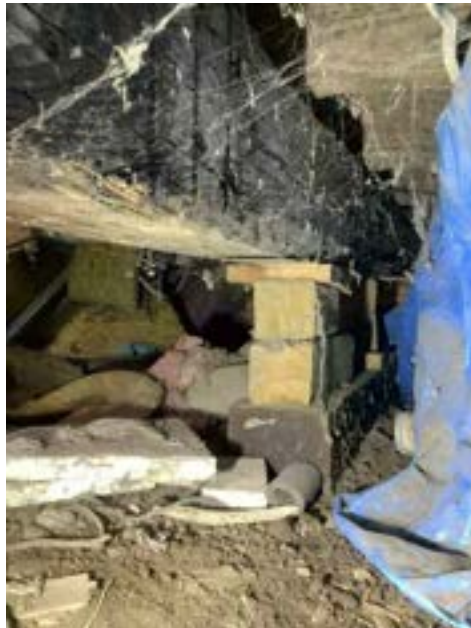
Due to the limitations preventing access to the complete crawl space the inspector was unable to fully evaluate the area for pest/rodent activity. We recommend a re-inspection by a qualified individual to ensure no issues are present.

Limitations/Obstructions - Crawl Space (Representative Picture)

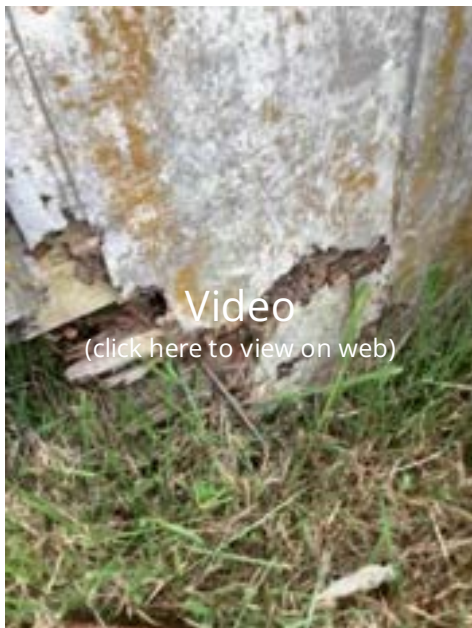
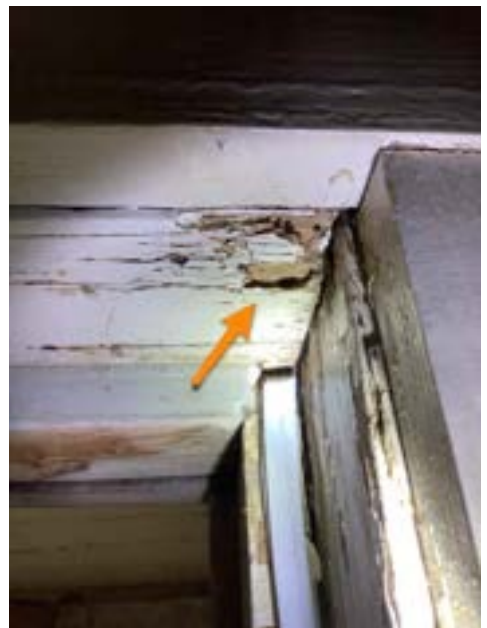
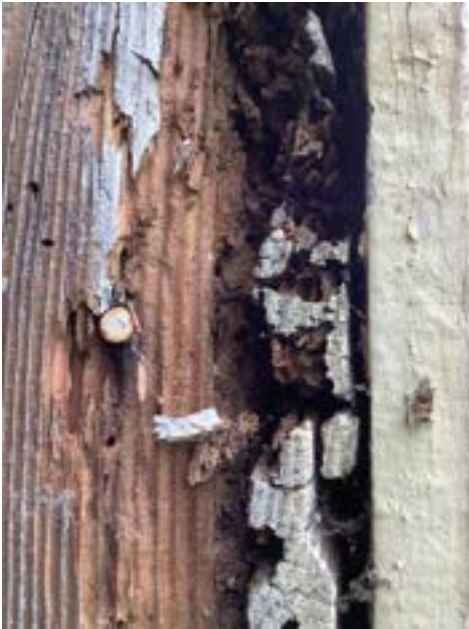
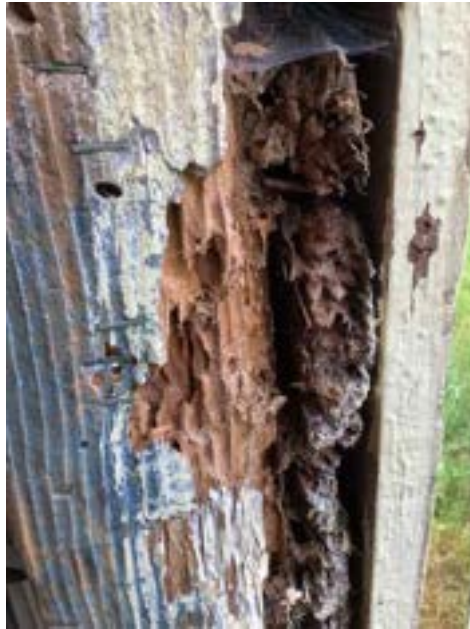
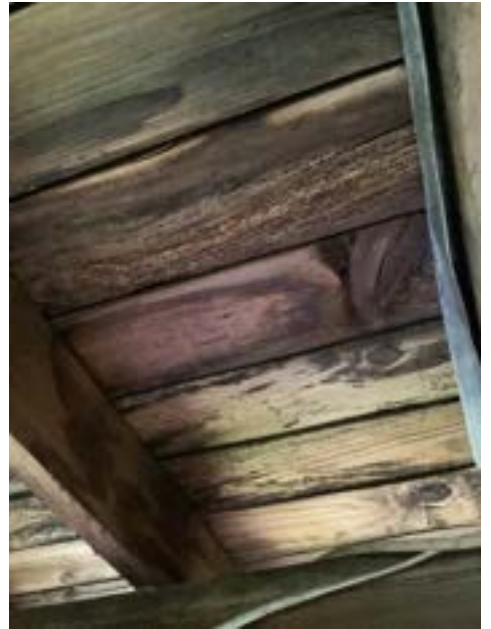
Signs of Wood Destroying Insects (Representative Picture)

Signs of Wood Destroying Insects
(Representative Picture)

Contact a qualified pest control specialist.
